HOME INSPECTION REPORT

Inspection
Date: 11/06/2017

Prepared For:
Location: Clearwater FL 33756 Prepared By: Gary
Home Inspections Inc.
Seminole Fl. 33776

Report Number: 6816

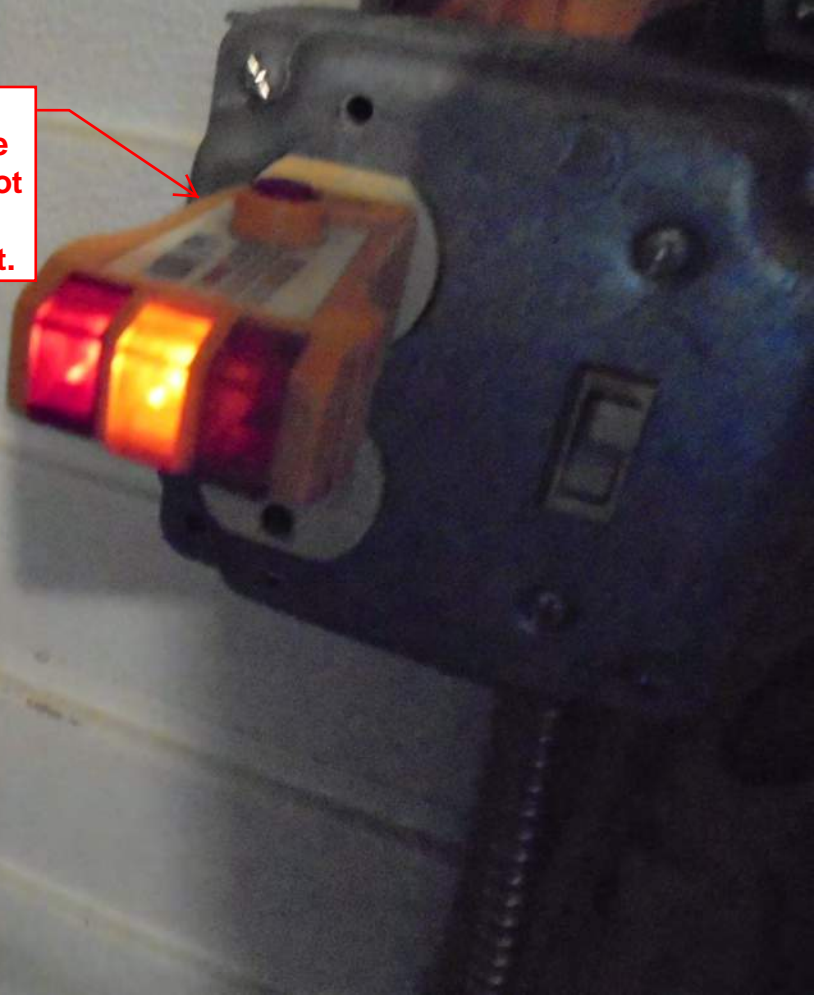
**Rear out door
shed has reverse
polarity and is not
on a GFCI
controlled circuit.**

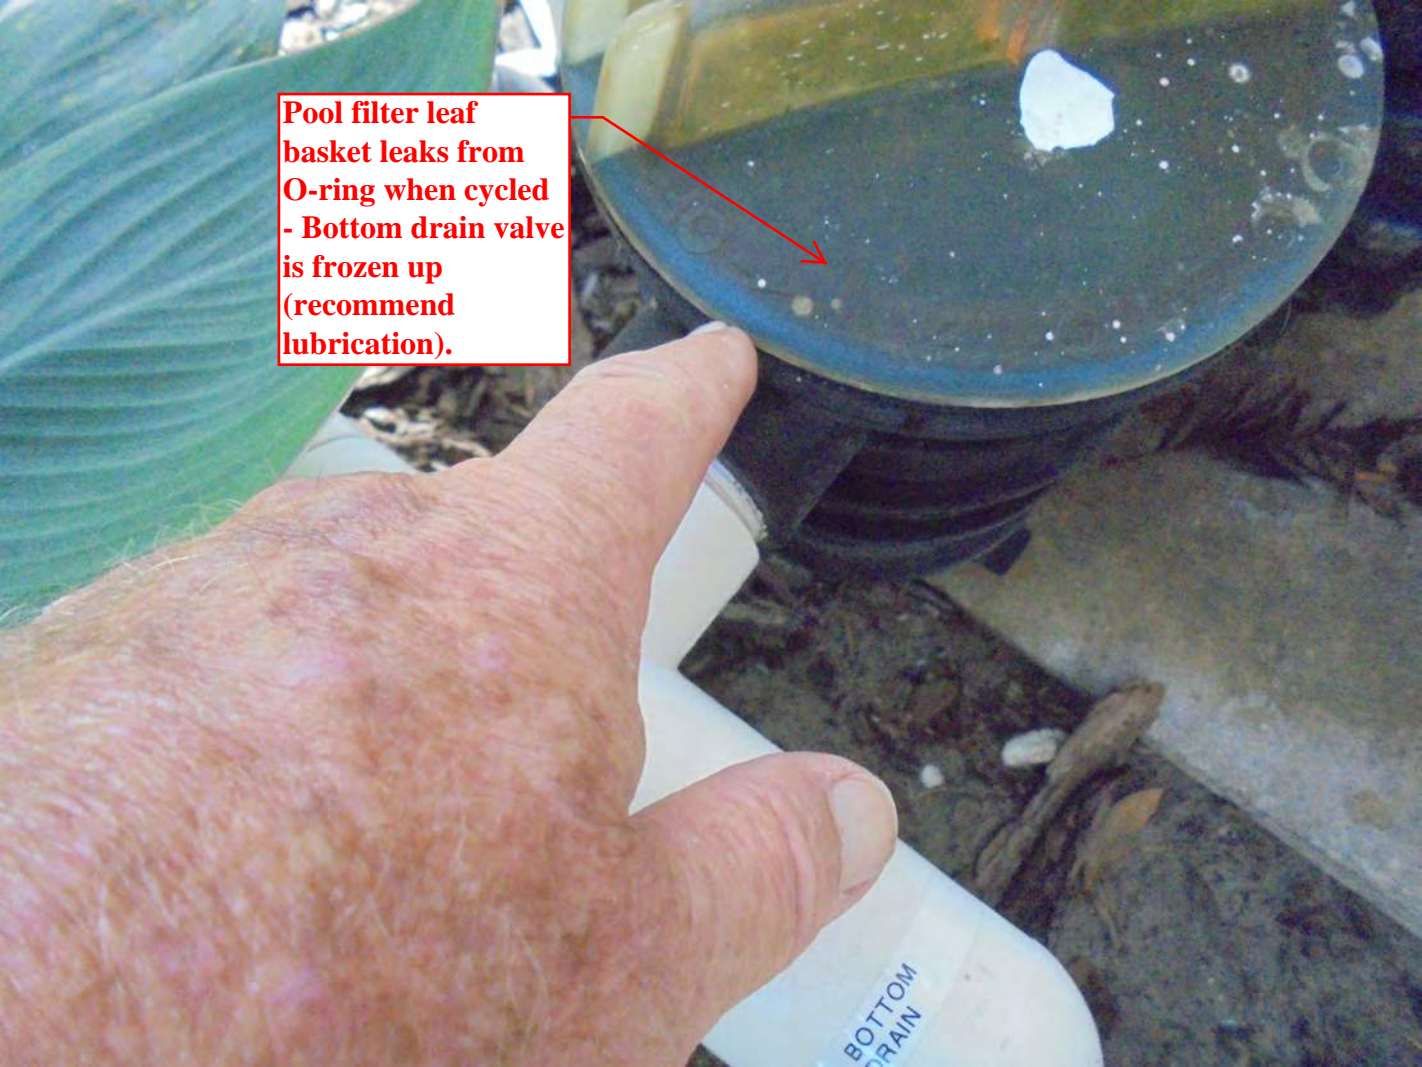
Pool filter leaf basket leaks from O-ring when cycled - Bottom drain valve is frozen up (recommend lubrication).

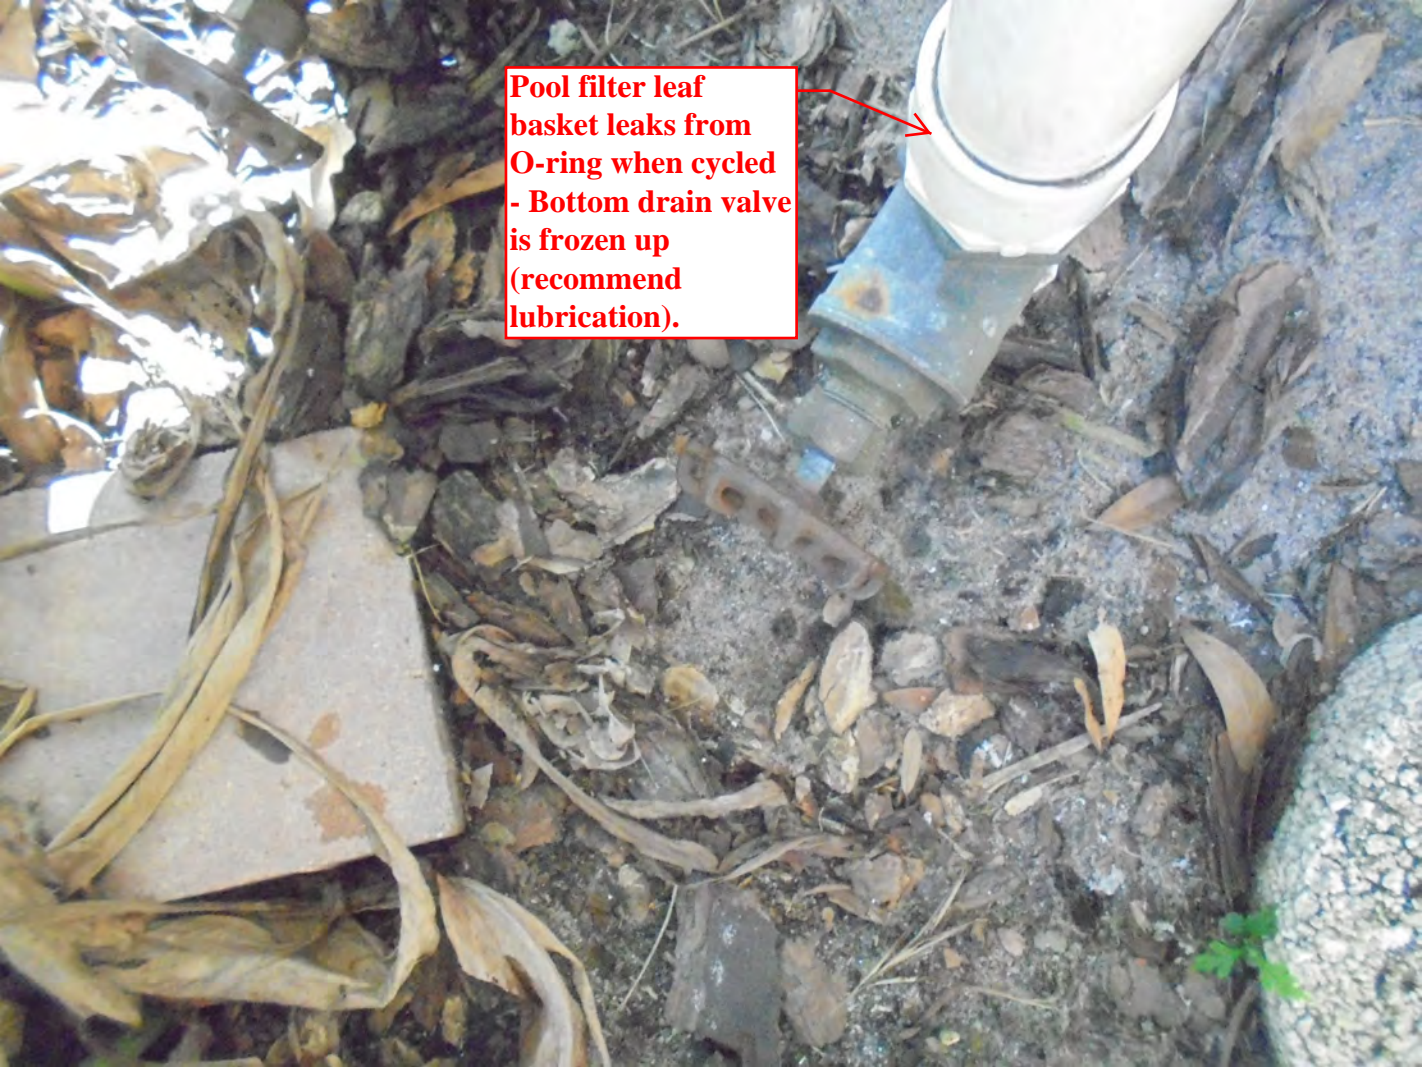
Pool filter leaf basket leaks from O-ring when cycled - Bottom drain valve is frozen up (recommend lubrication).

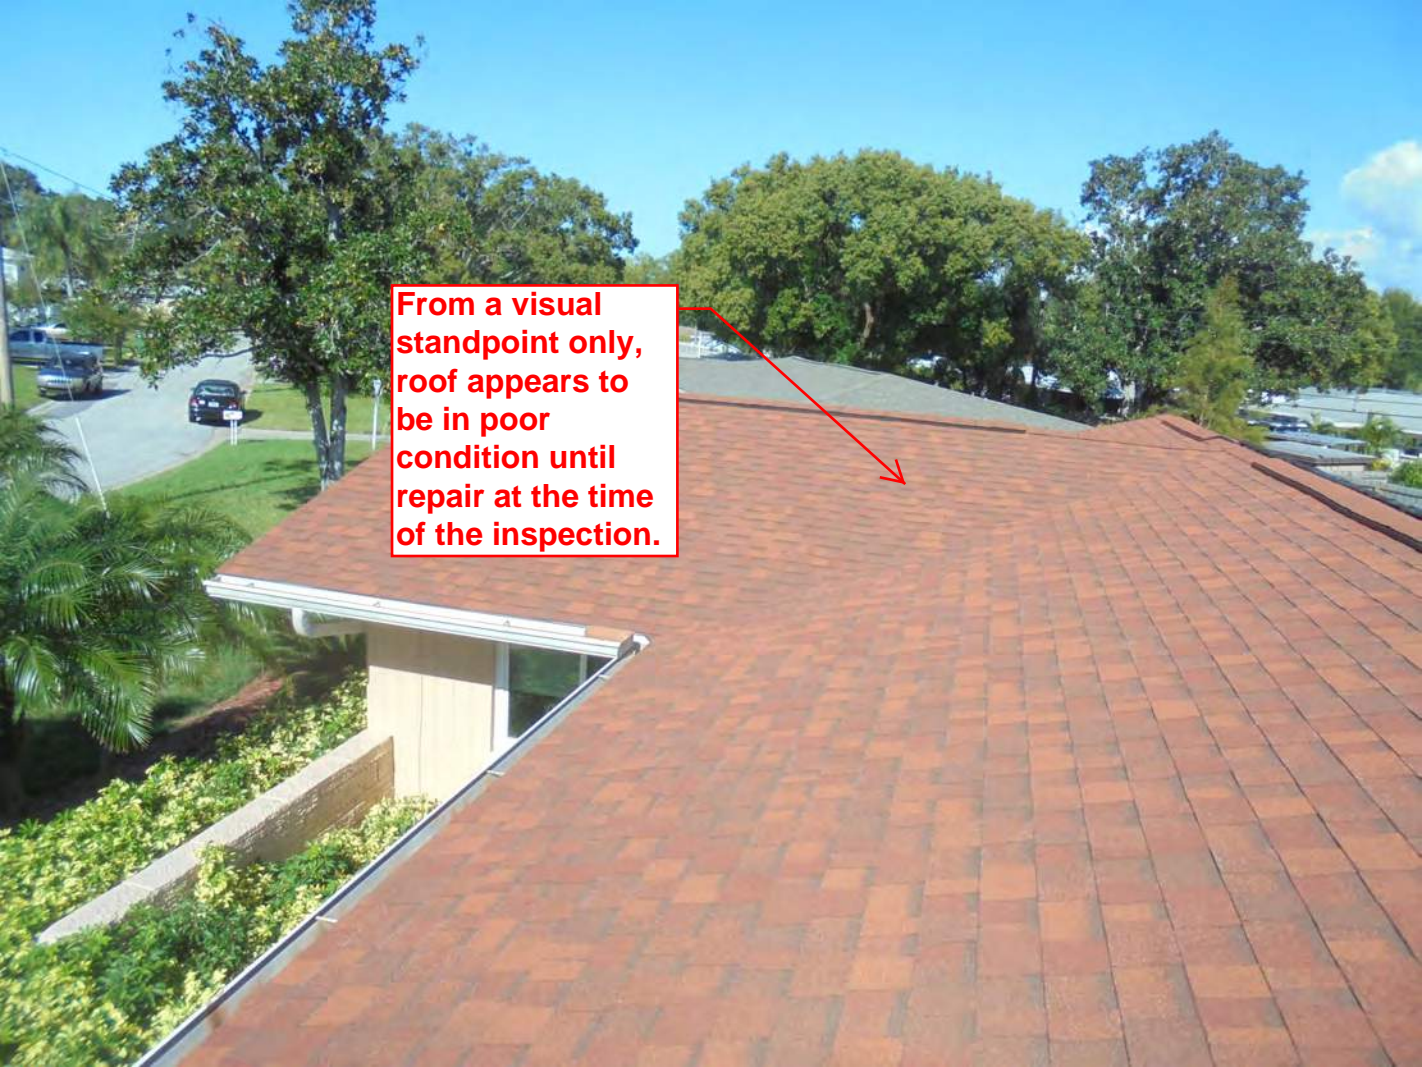
From a visual standpoint only, roof appears to be in poor condition until repair at the time of the inspection.

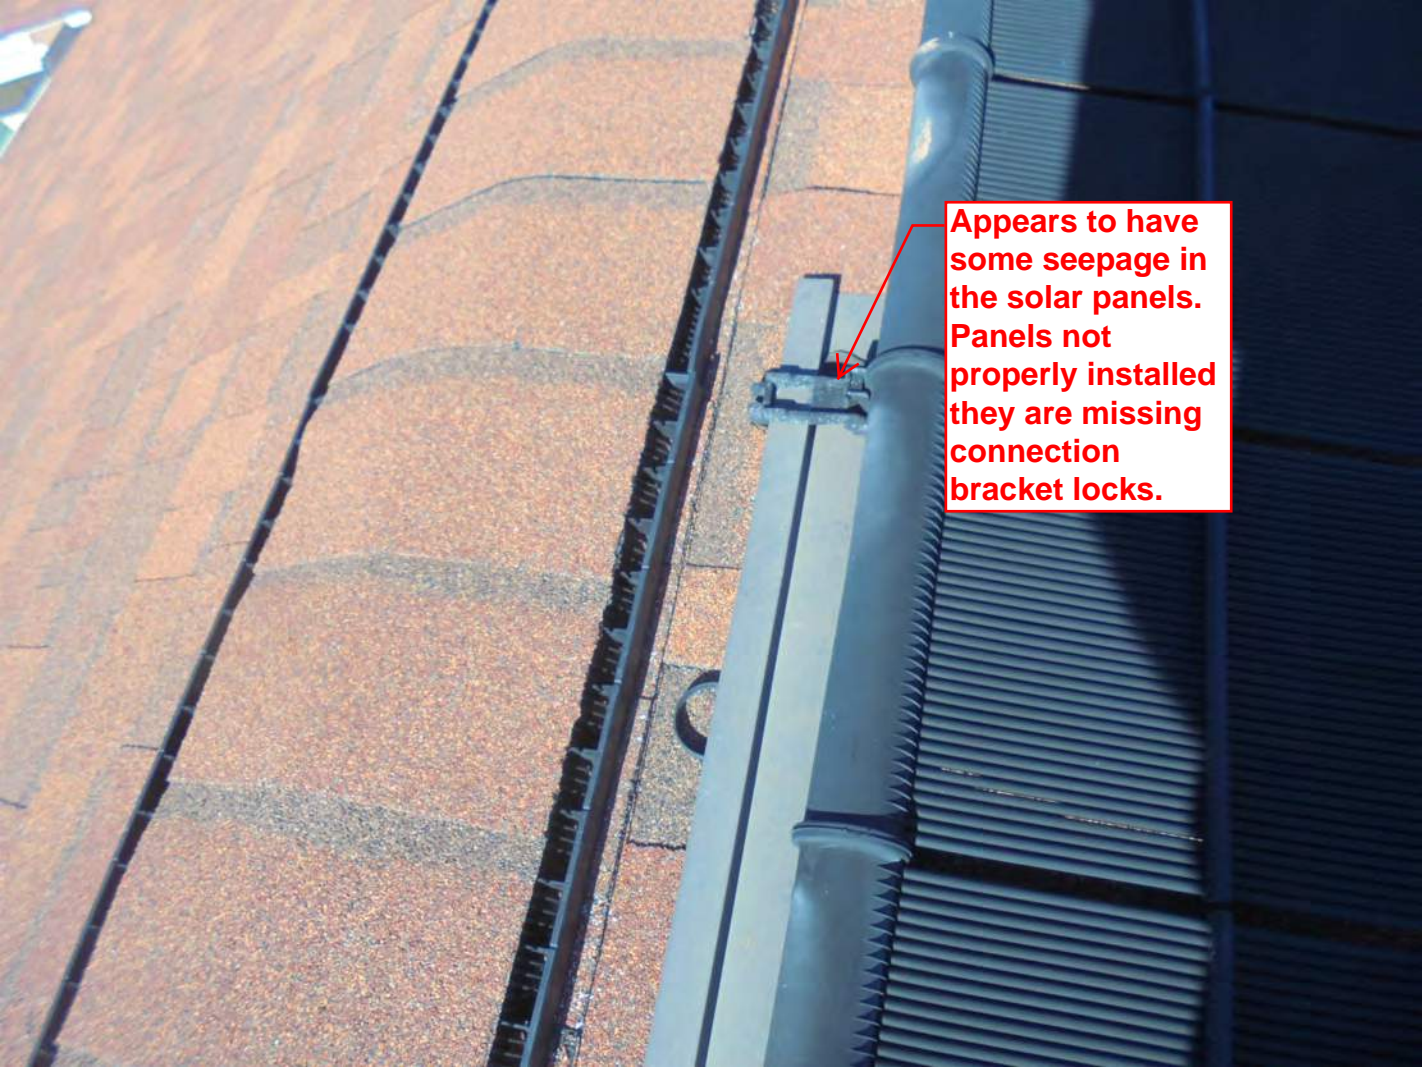
Appears to have some seepage in the solar panels. Panels not properly installed they are missing connection bracket locks.

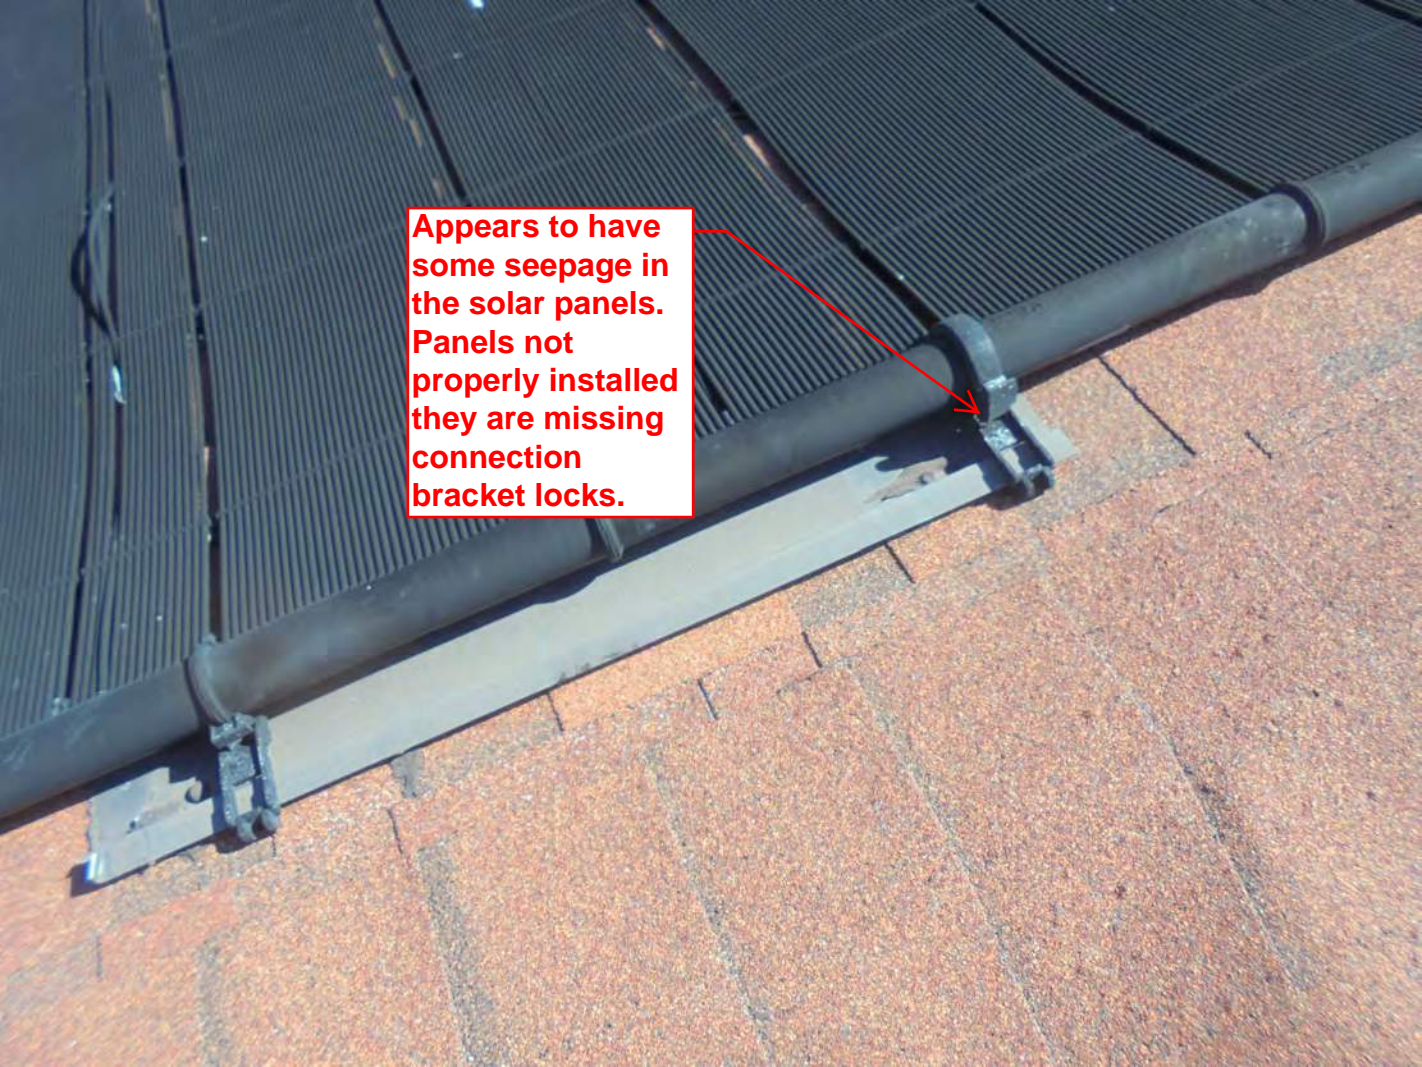
Appears to have some seepage in the solar panels. Panels not properly installed they are missing connection bracket locks.

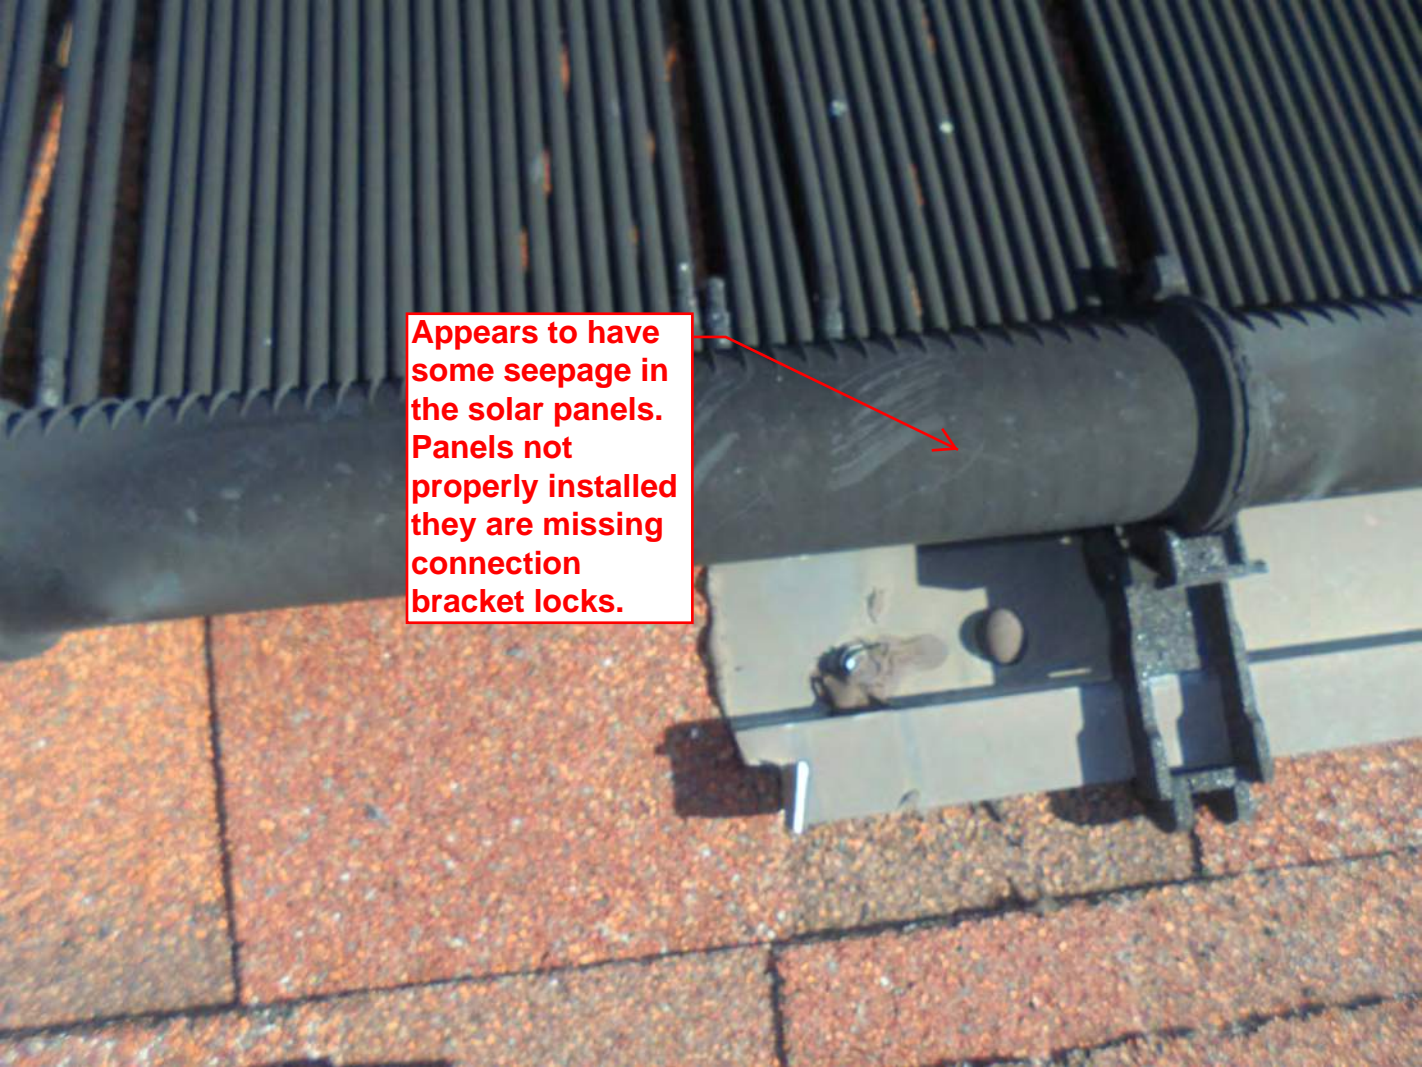
Appears to have some seepage in the solar panels. Panels not properly installed they are missing connection bracket locks.

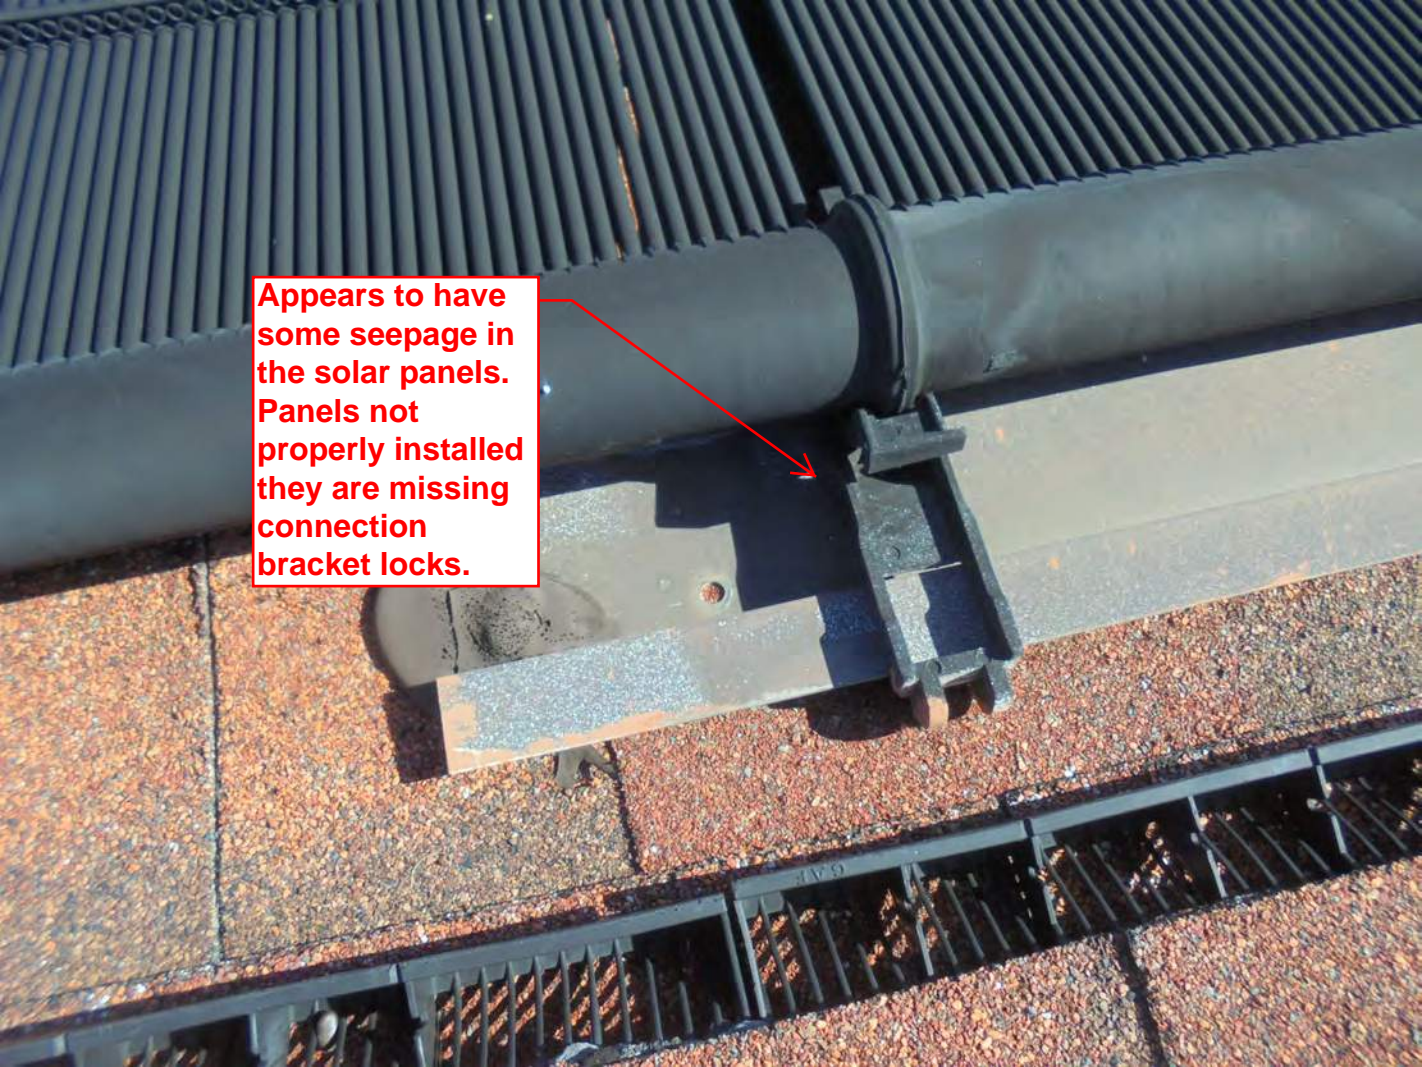
Appears to have some seepage in the solar panels. Panels not properly installed they are missing connection bracket locks.

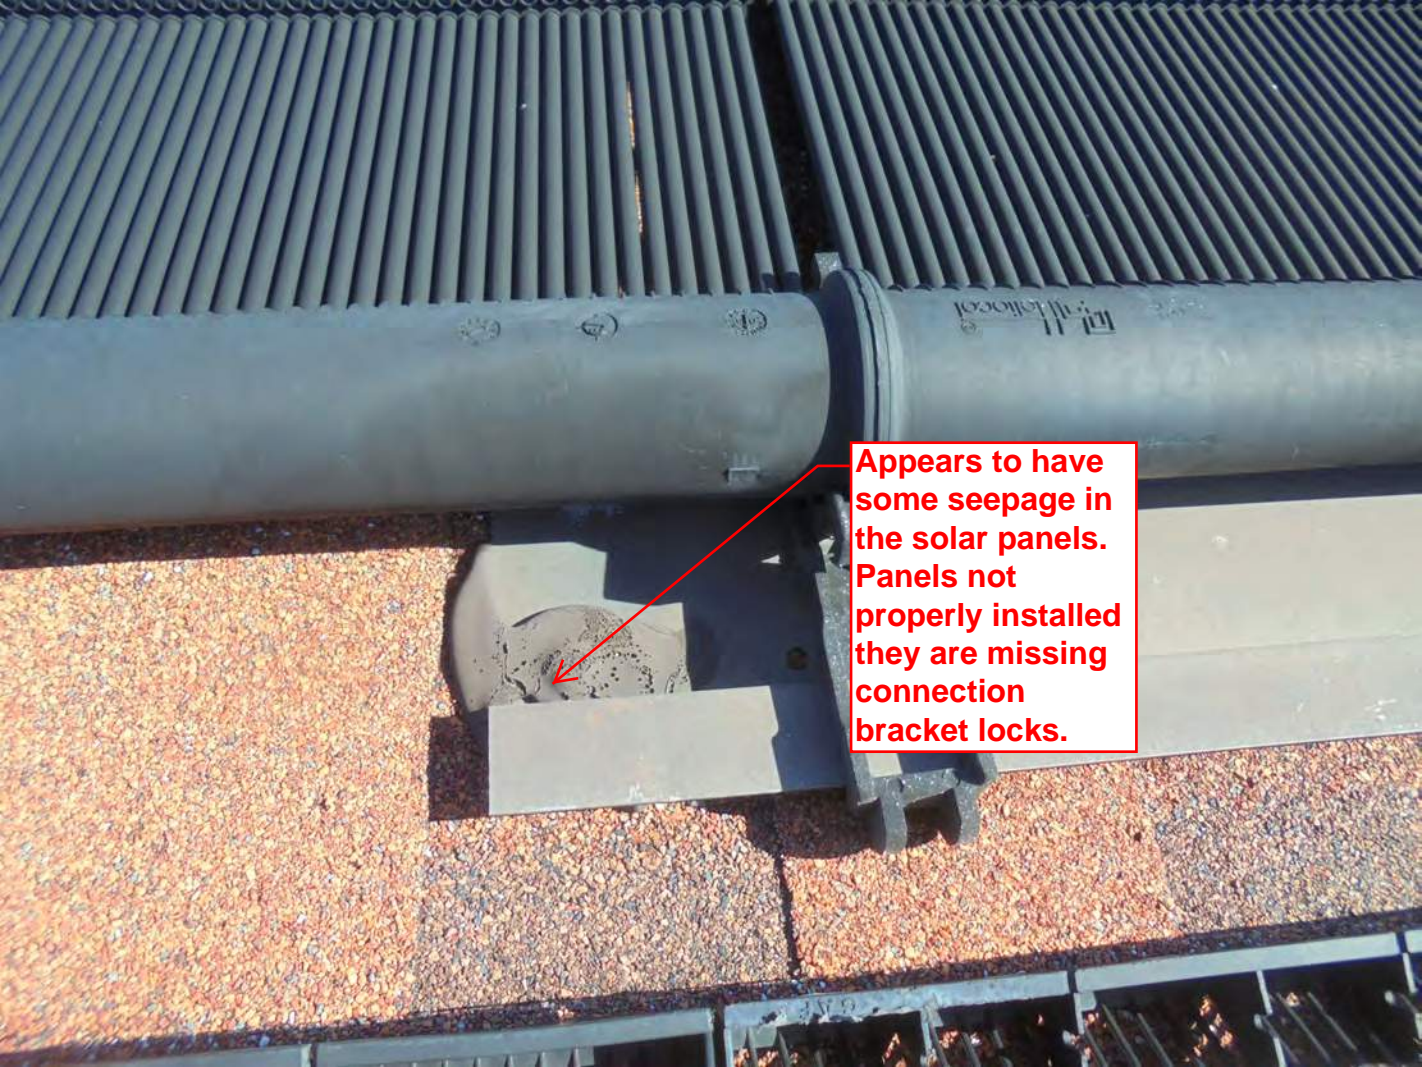
Appears to have some seepage in the solar panels. Panels not properly installed they are missing connection bracket locks.

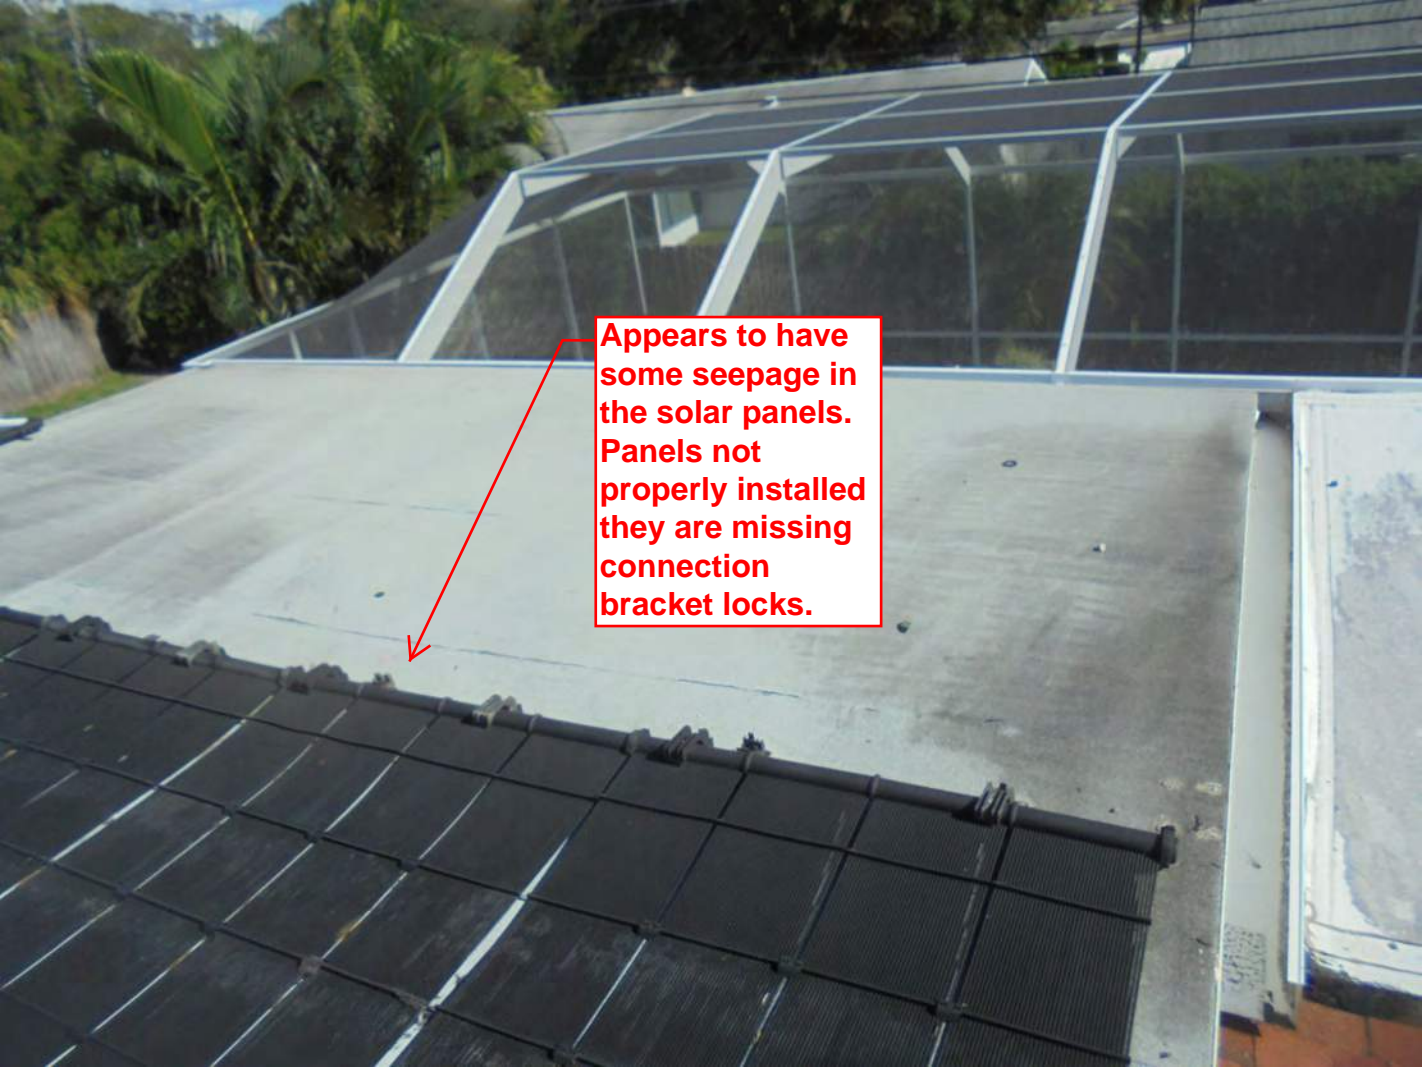
Appears to have some seepage in the solar panels. Panels not properly installed they are missing connection bracket locks.

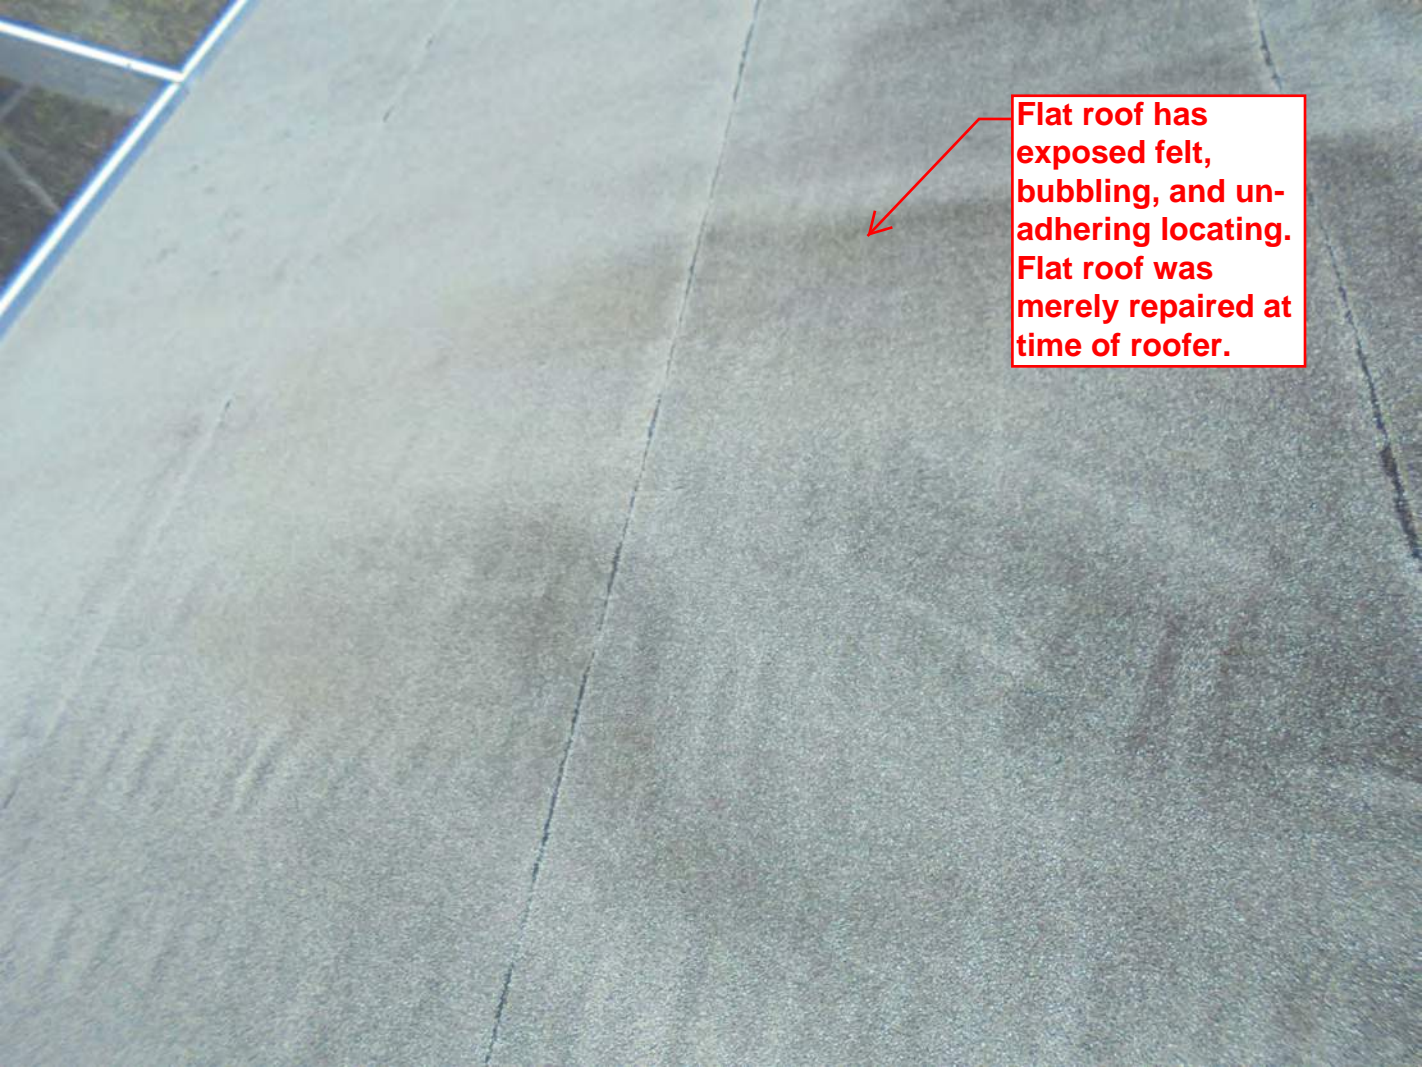
Flat roof has exposed felt, bubbling, and unadhering locating. Flat roof was merely repaired at time of roofer.

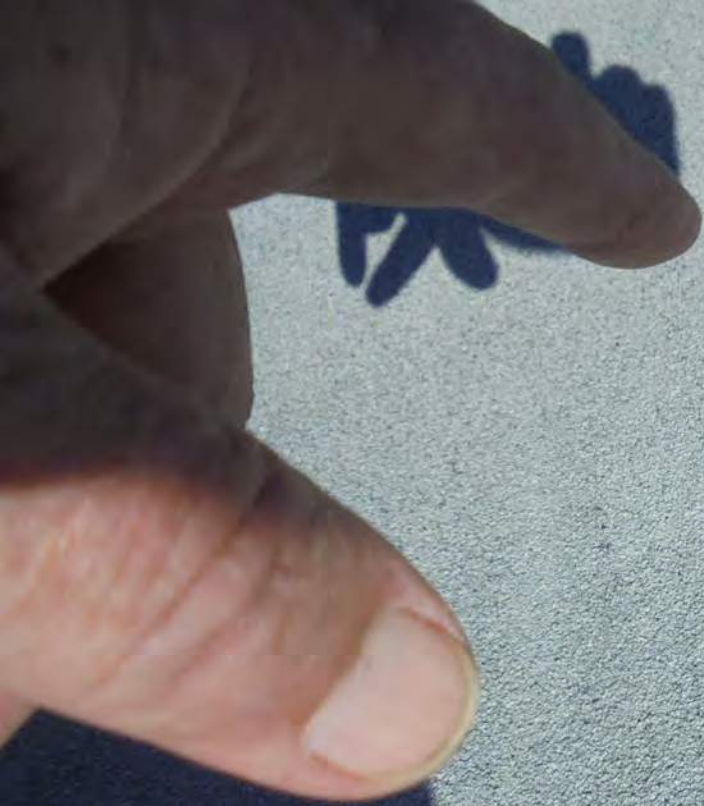
Flat roof has exposed felt, bubbling, and unadhering locating. Flat roof was merely repaired at time of roofer.

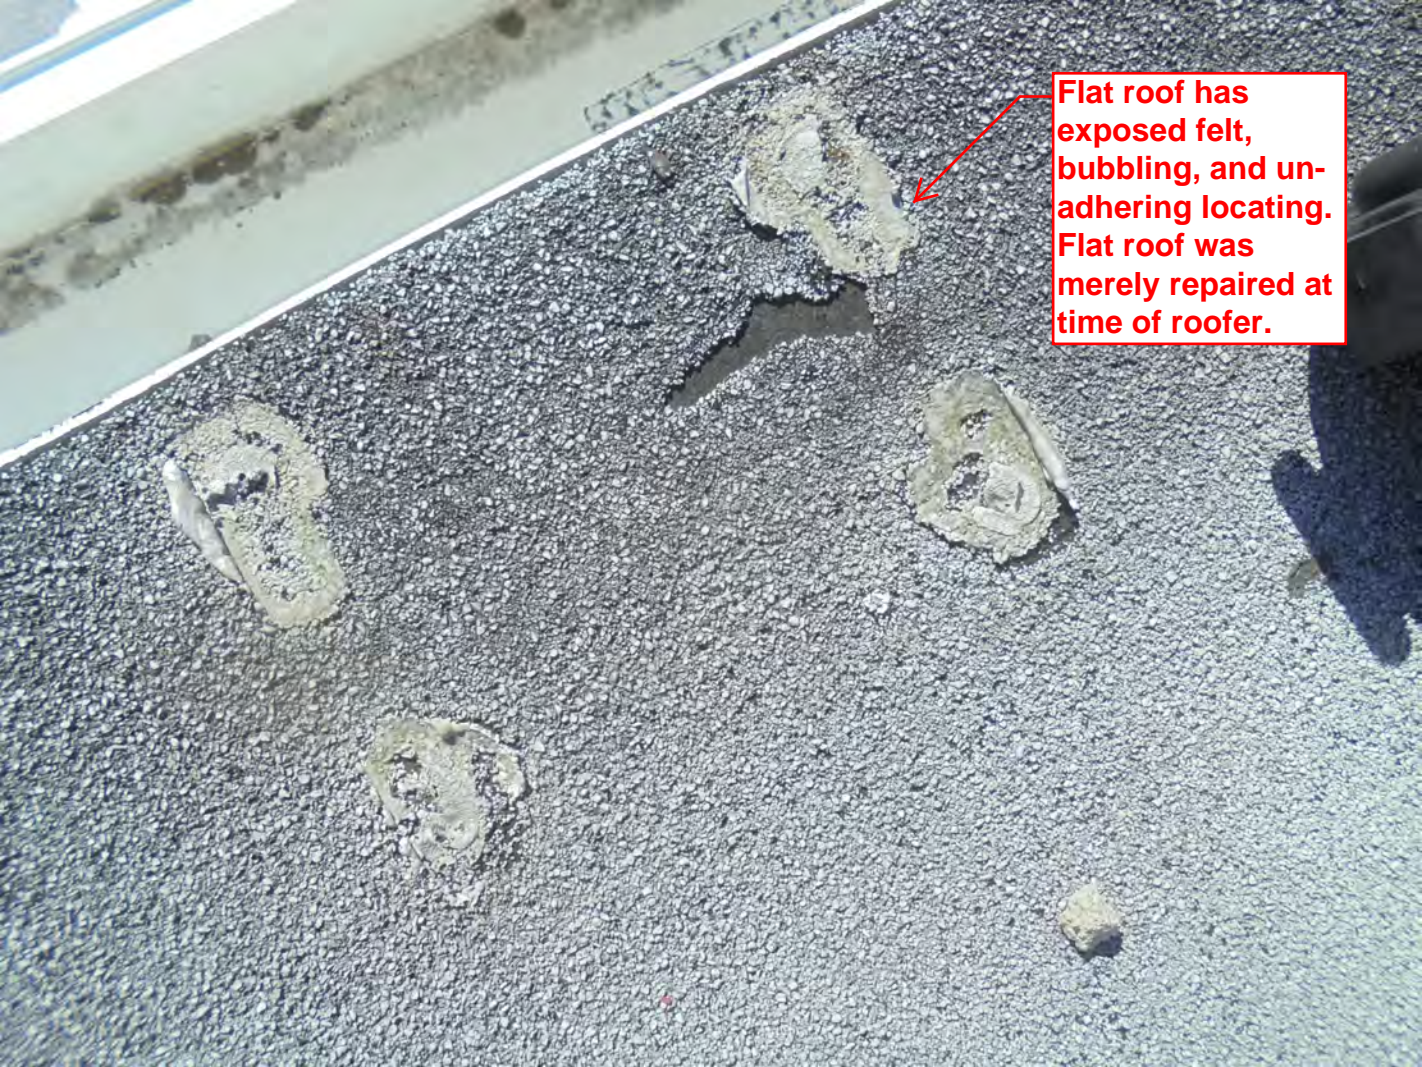
Flat roof has exposed felt, bubbling, and unadhering locating. Flat roof was merely repaired at time of roofer.

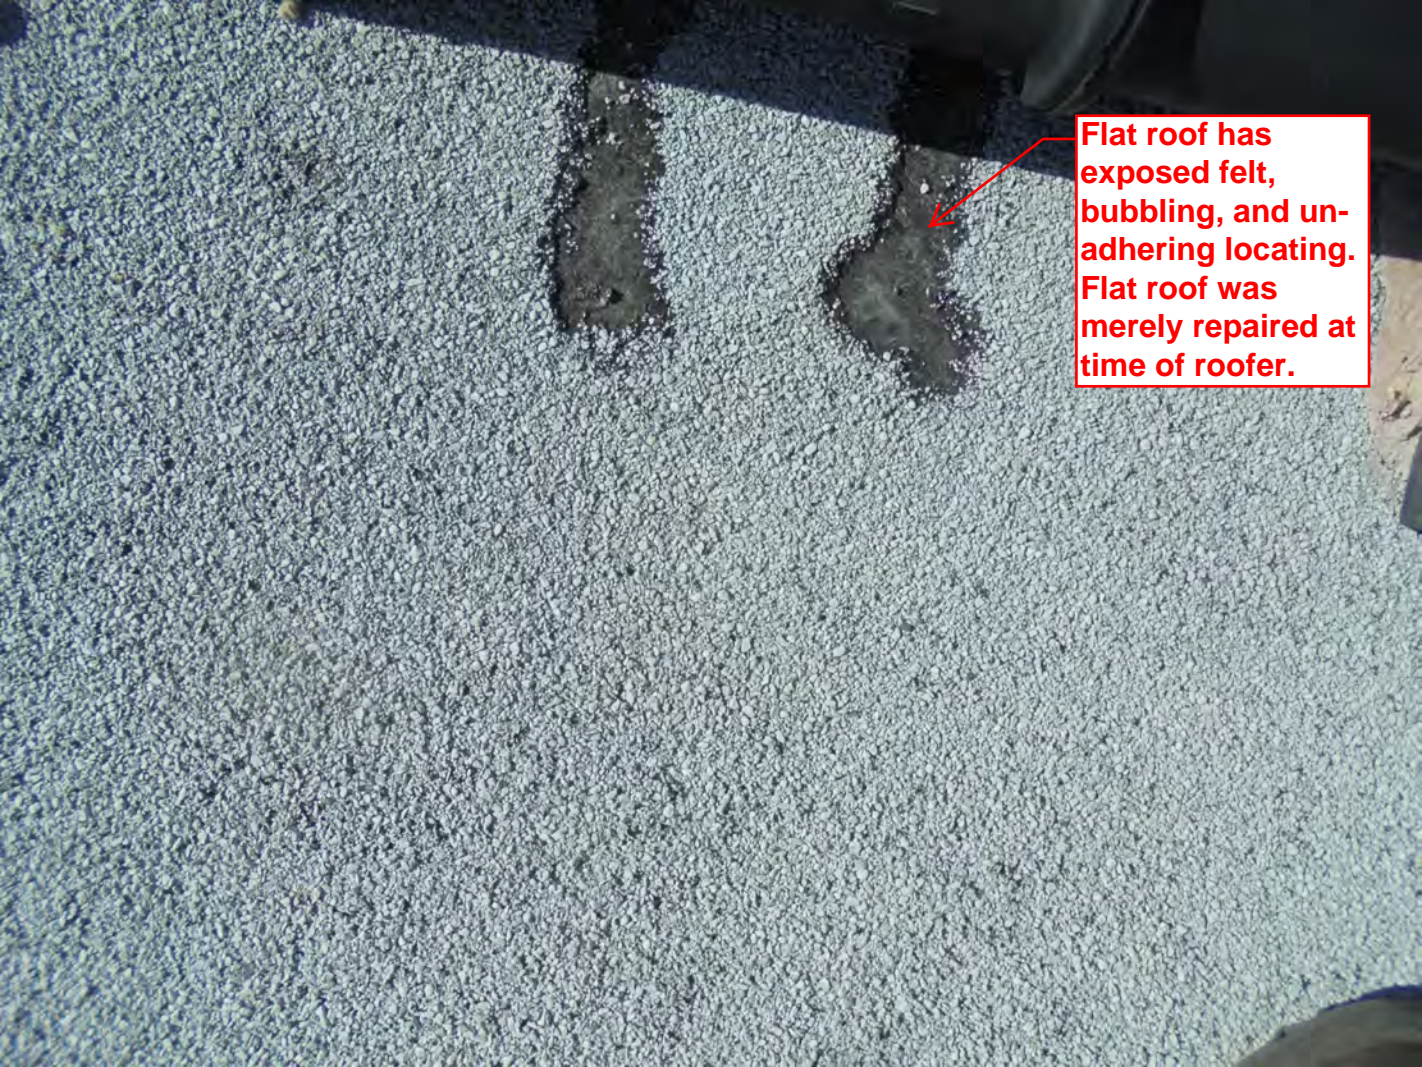
Flat roof has exposed felt, bubbling, and unadhering locating. Flat roof was merely repaired at time of roofer.

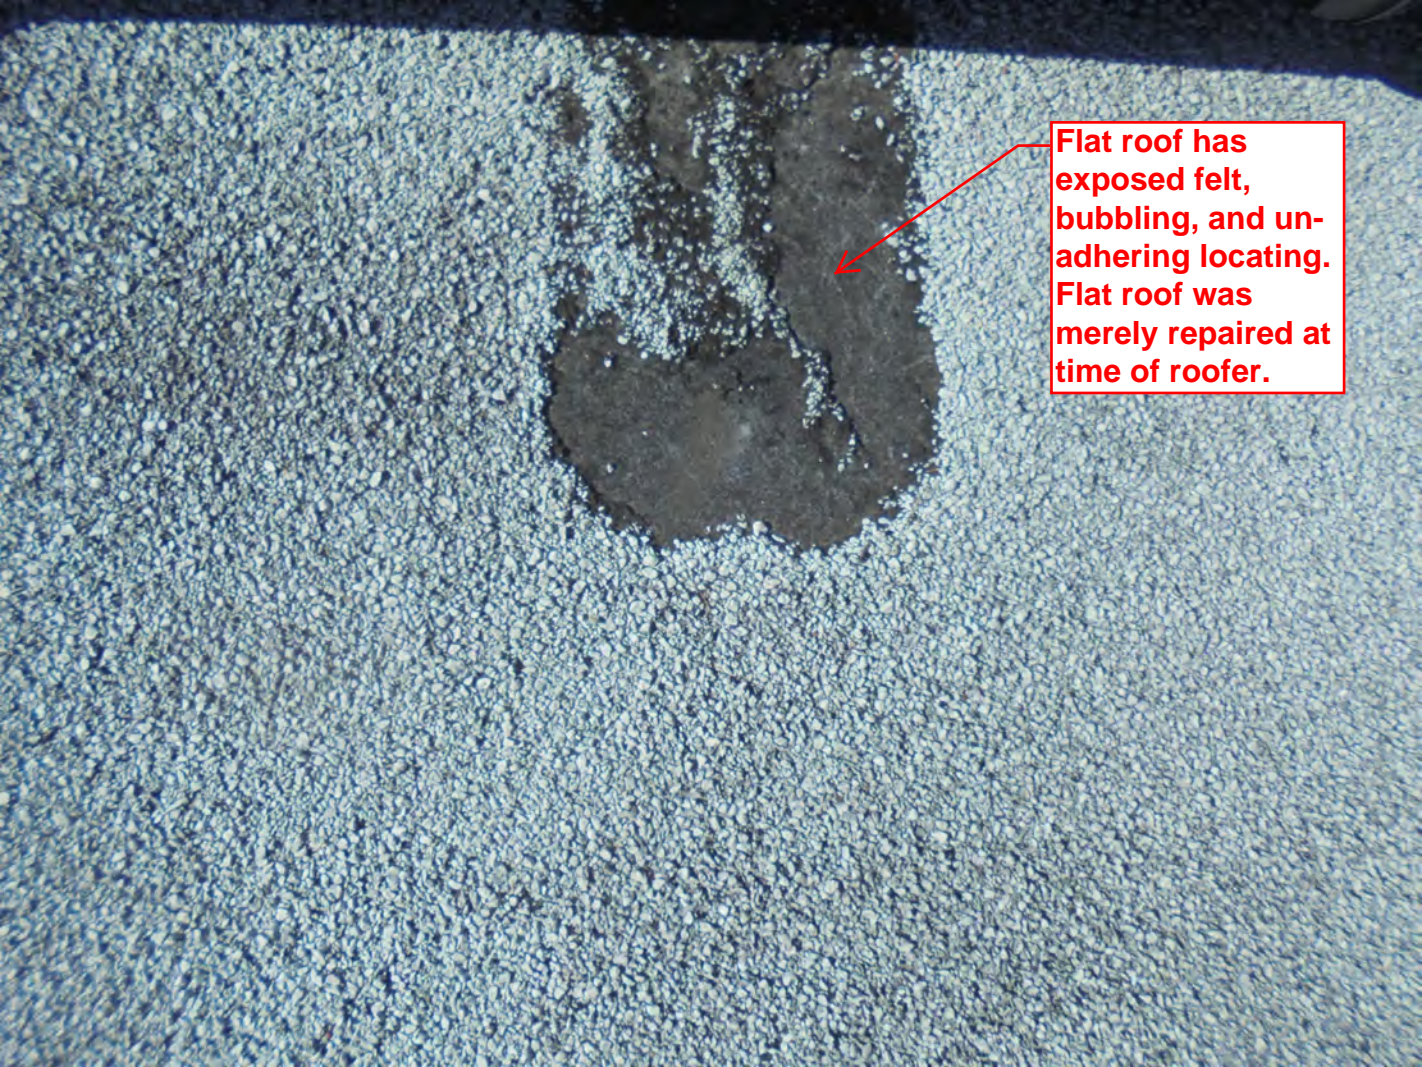
Flat roof has exposed felt, bubbling, and unadhering locating. Flat roof was merely repaired at time of roofer.

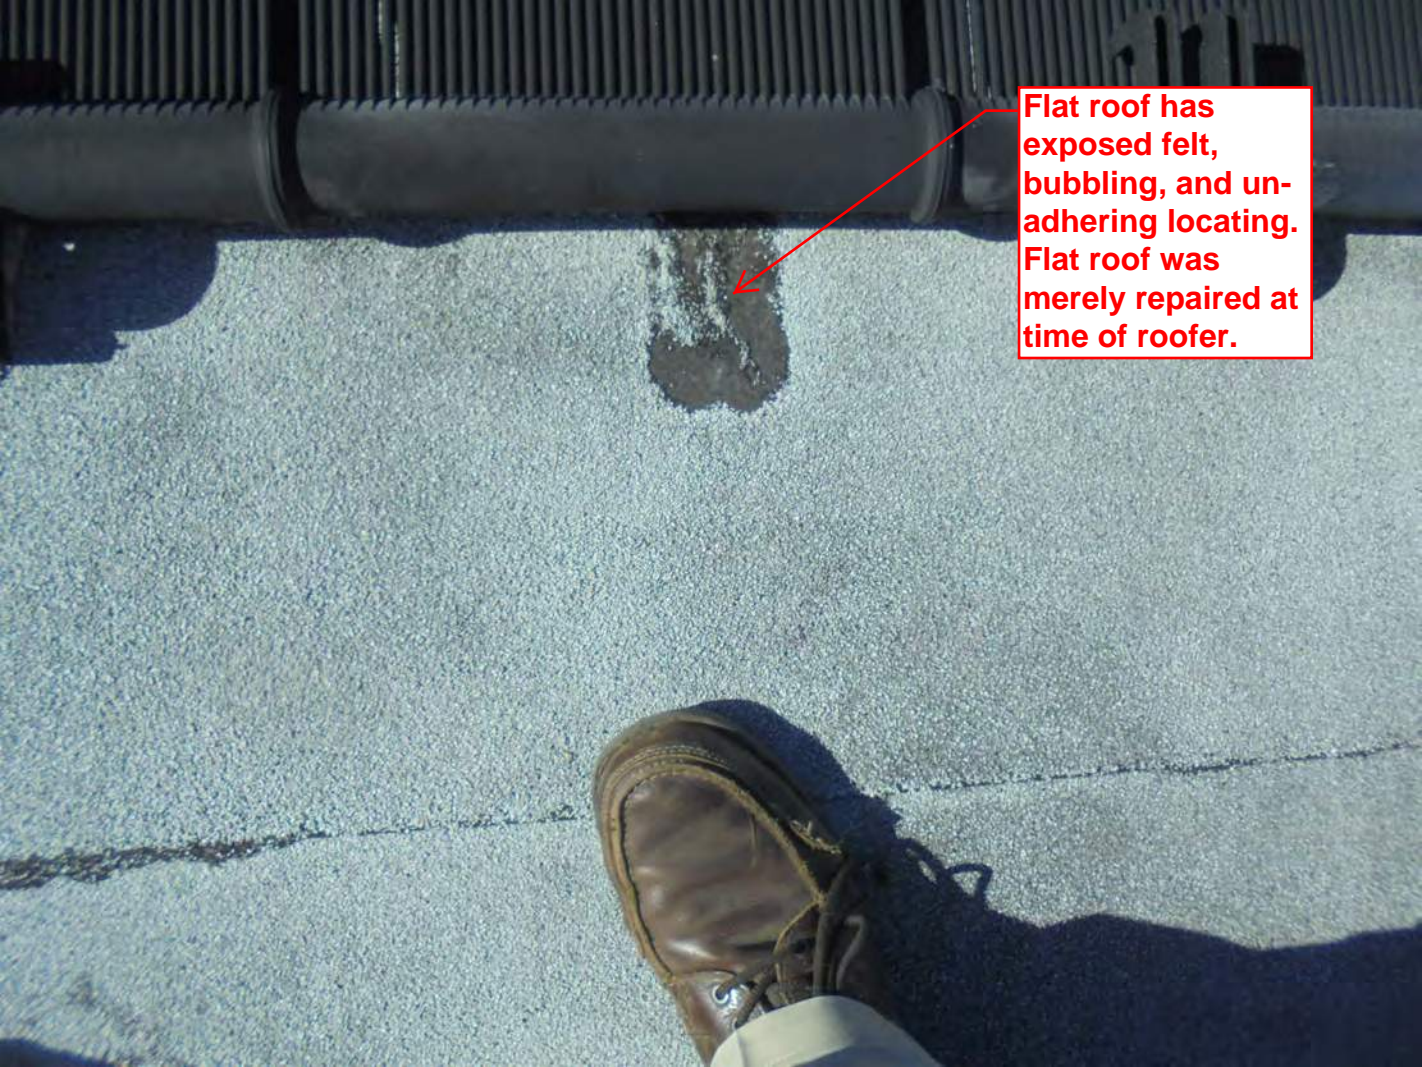
Flat roof has exposed felt, bubbling, and unadhering locating. Flat roof was merely repaired at time of roofer.
