HOME INSPECTION REPORT

Inspection
Date: 11/06/2017

Prepared For:
Location: Clearwater FL 33756 Prepared By: Gary
Home Inspections Inc.
Seminole Fl. 33776

Report Number: 6816

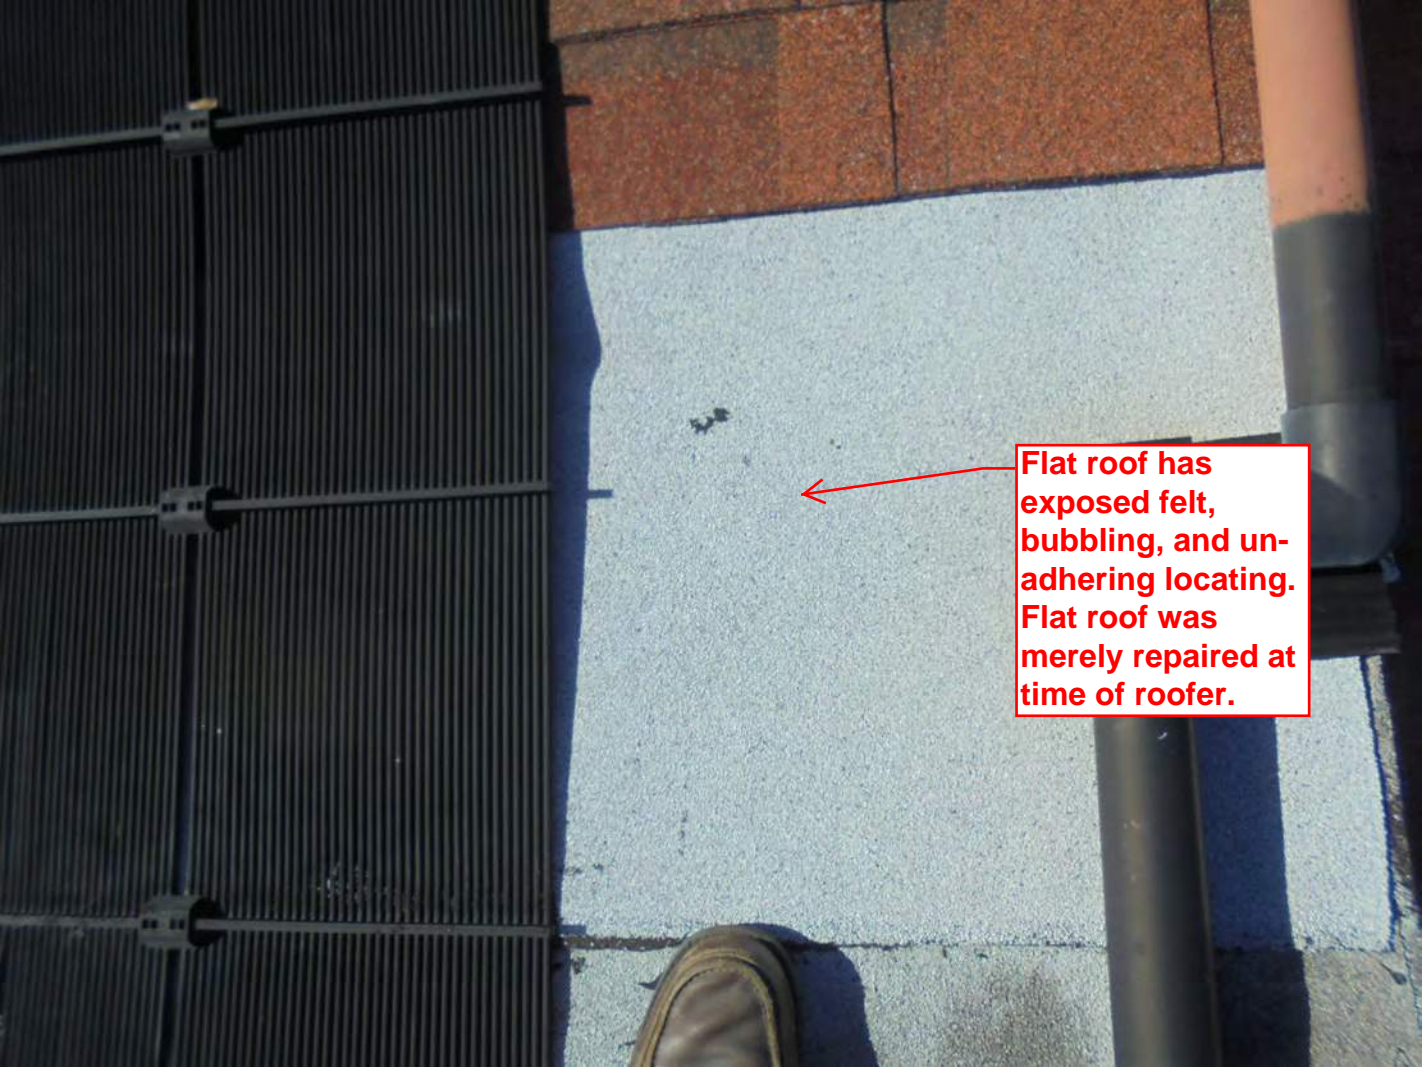
Flat roof has exposed felt, bubbling, and unadhering locating. Flat roof was merely repaired at time of roofer.

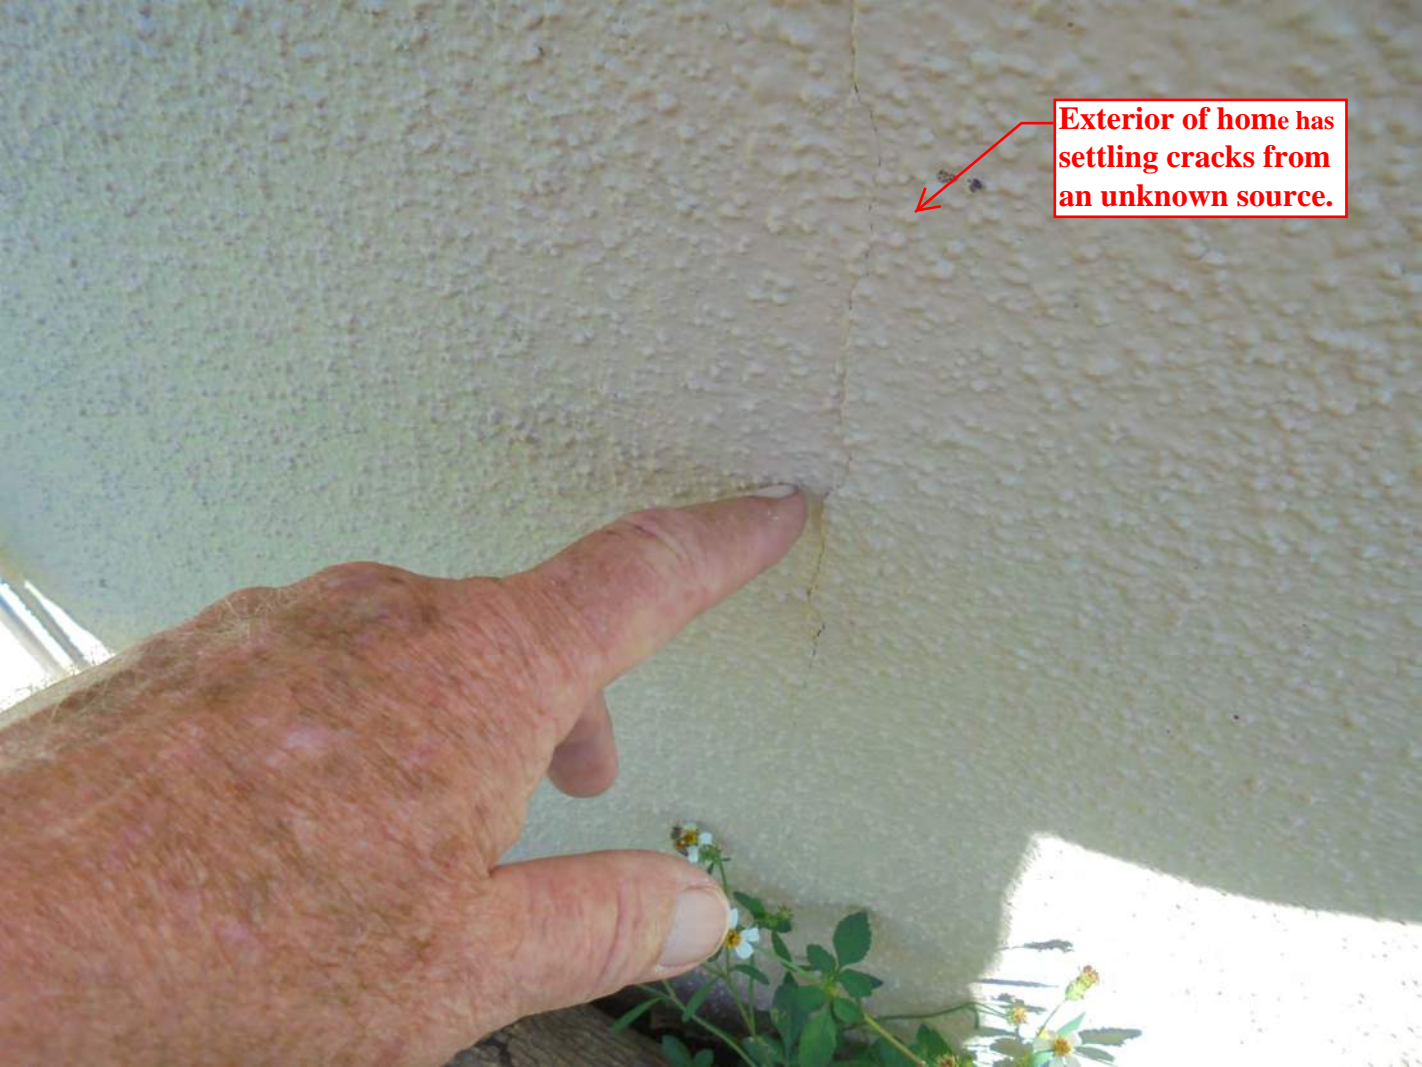
**Exterior of home has
settling cracks from
an unknown source.**

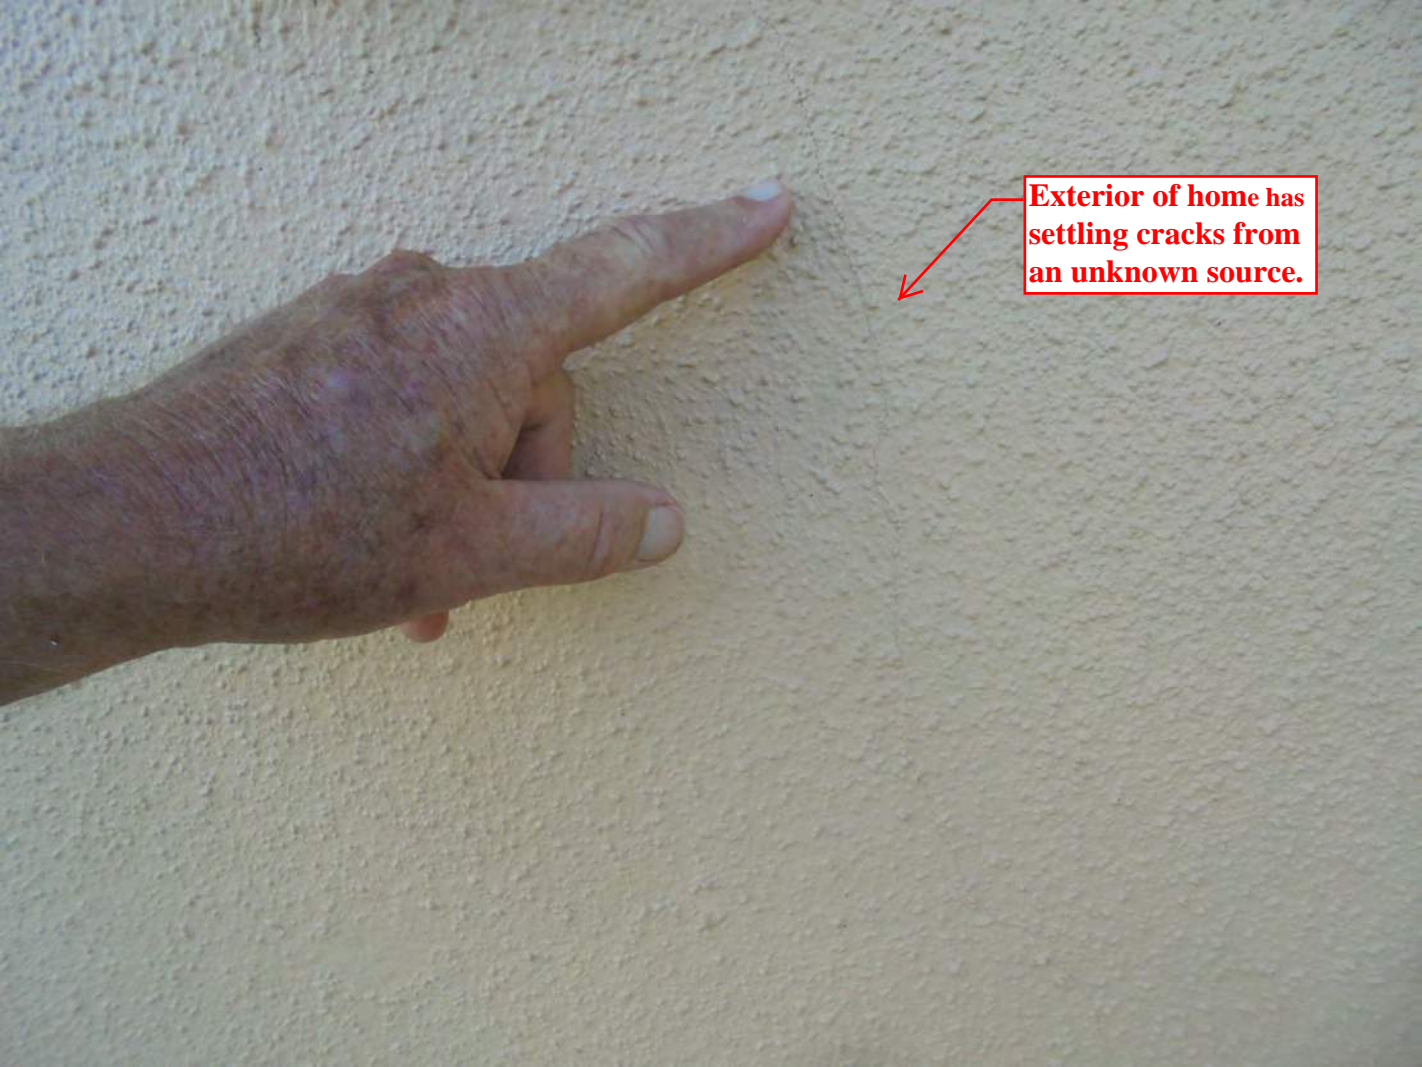
Exterior of home has settling cracks from an unknown source.

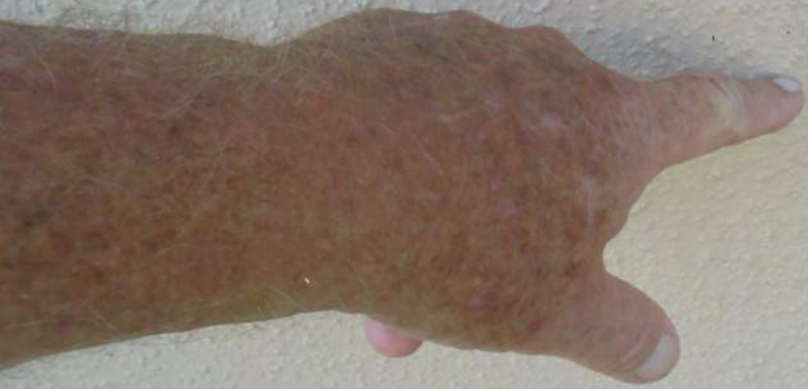
Exterior of home has settling cracks from an unknown source.

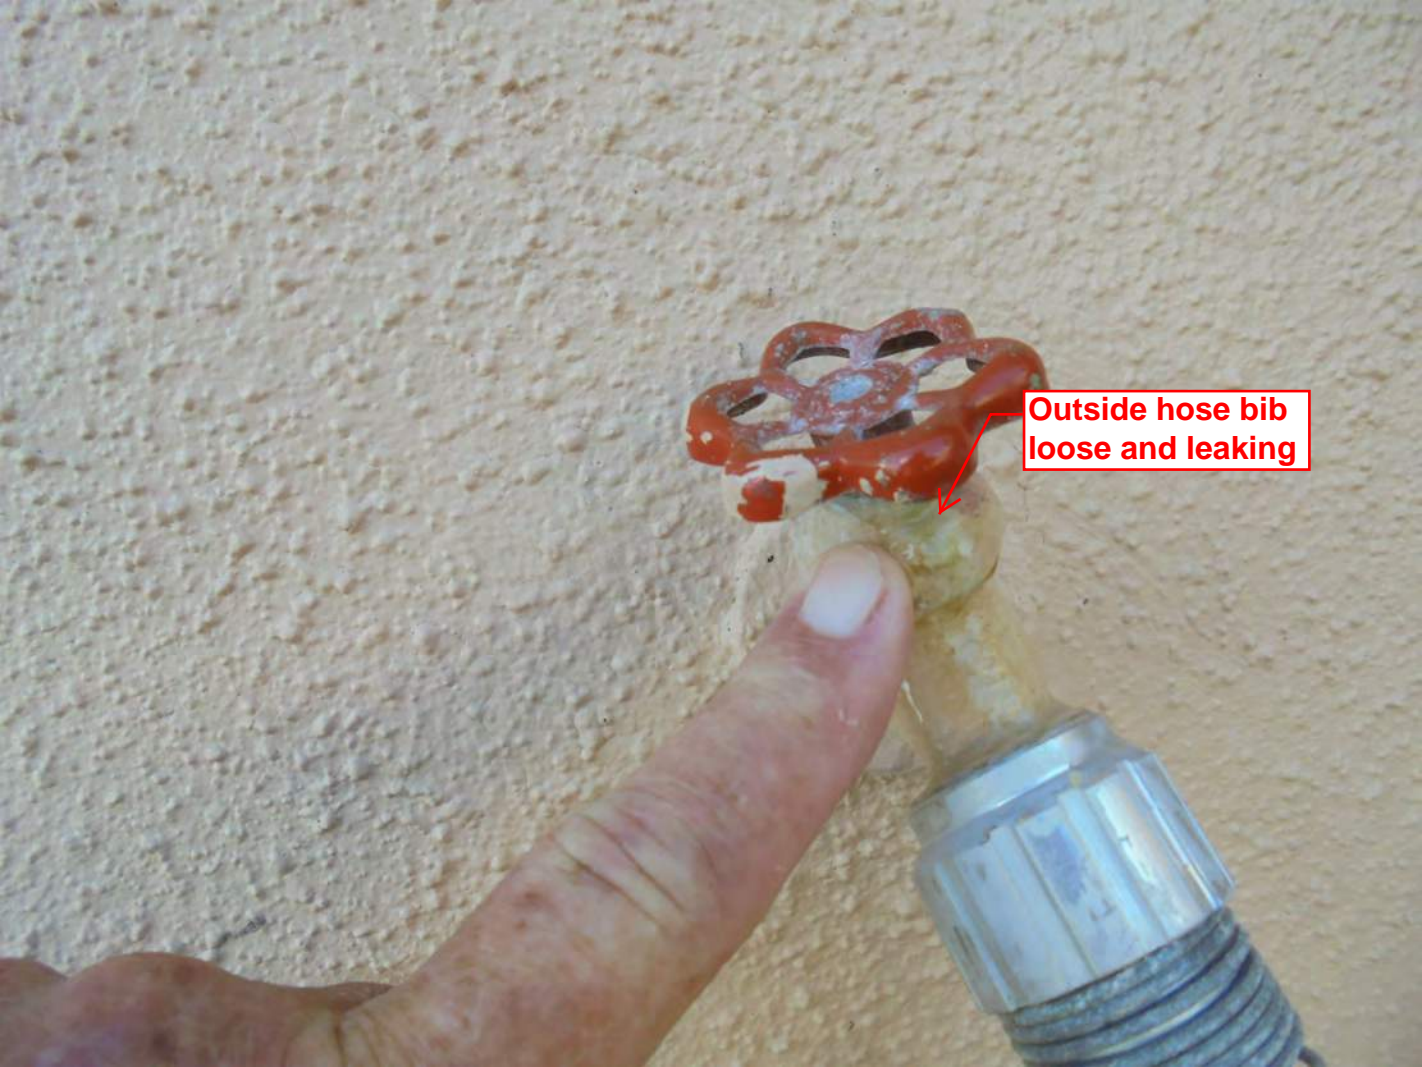
**Outside hose bib
loose and leaking**

**Garage door is
stuck and
damaged at
bottom**

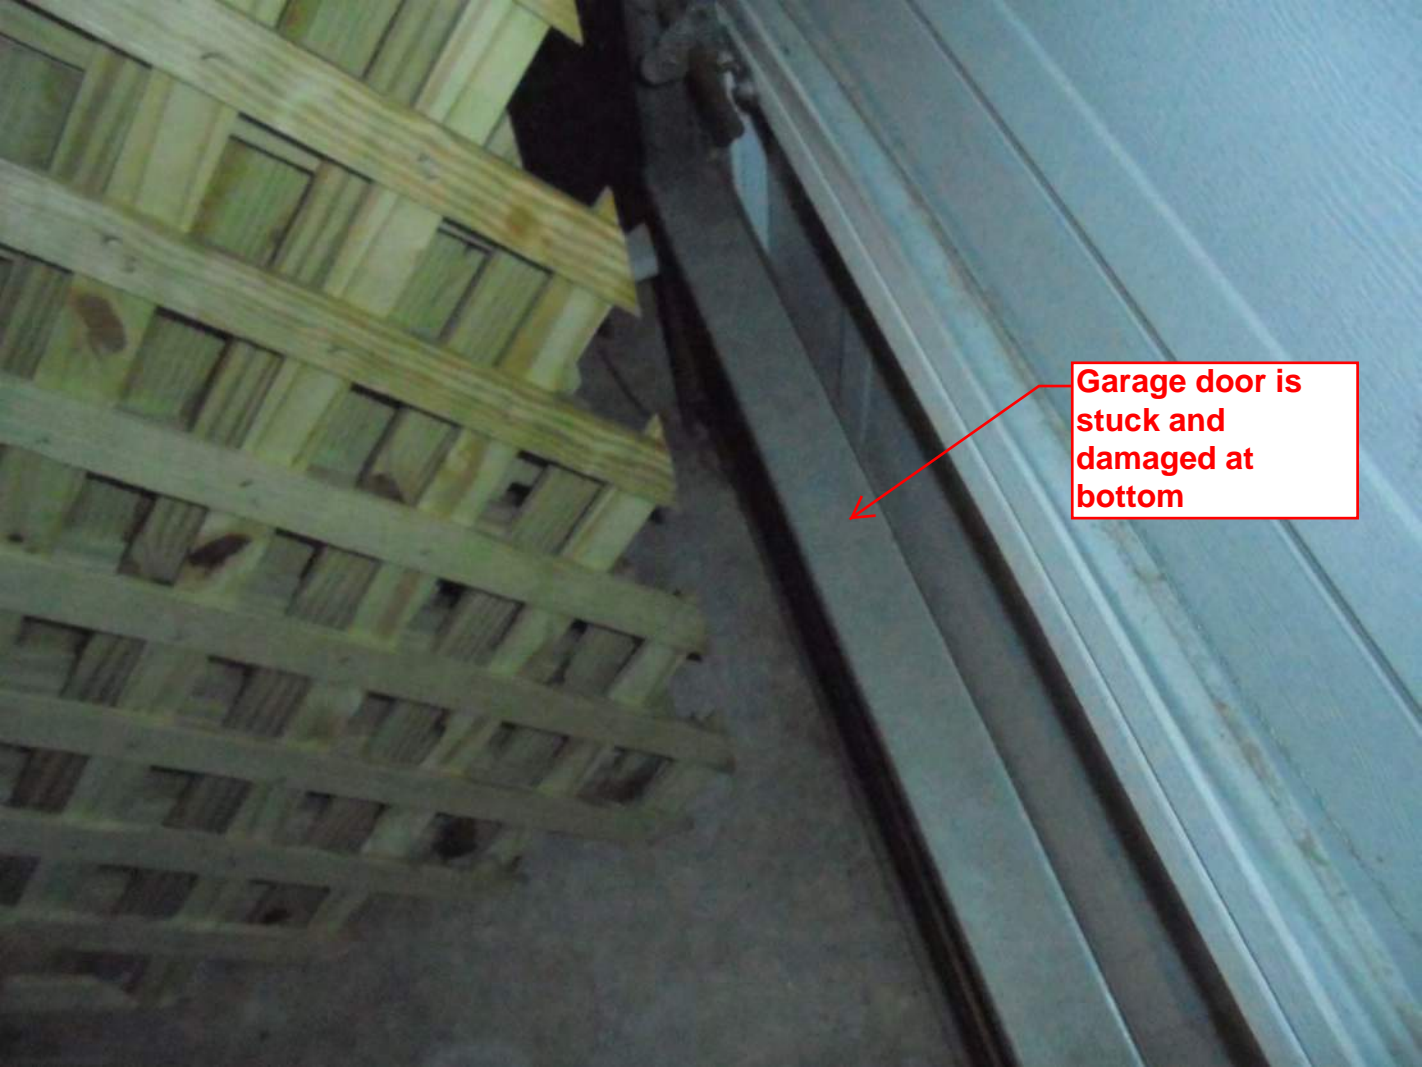
Garage door is stuck and damaged at bottom

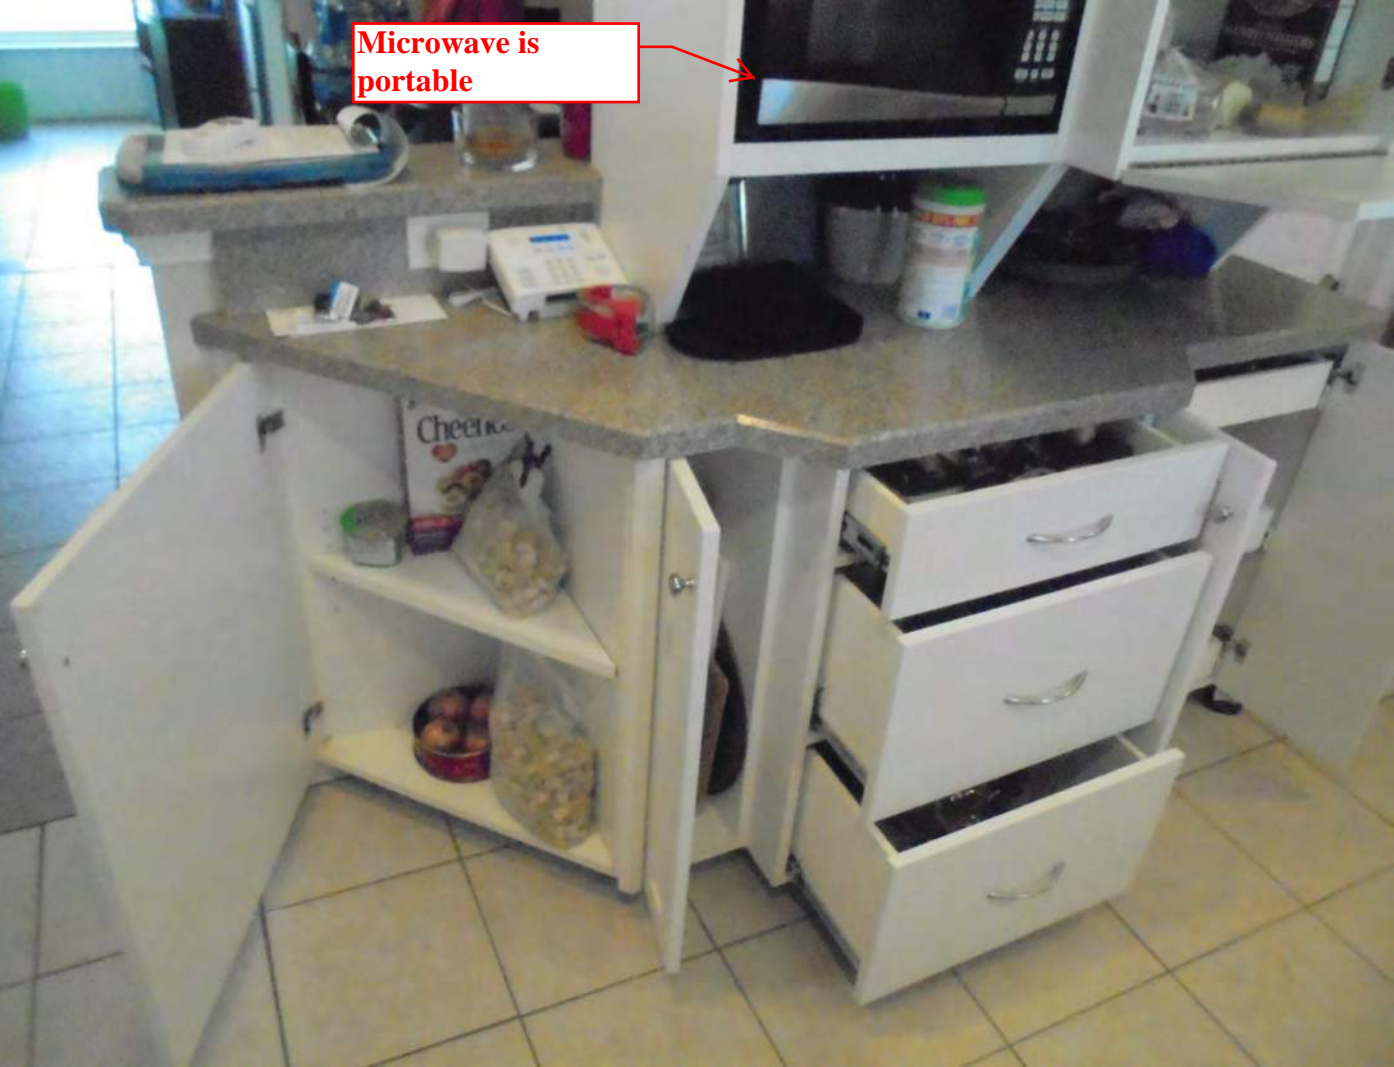
Microwave is portable

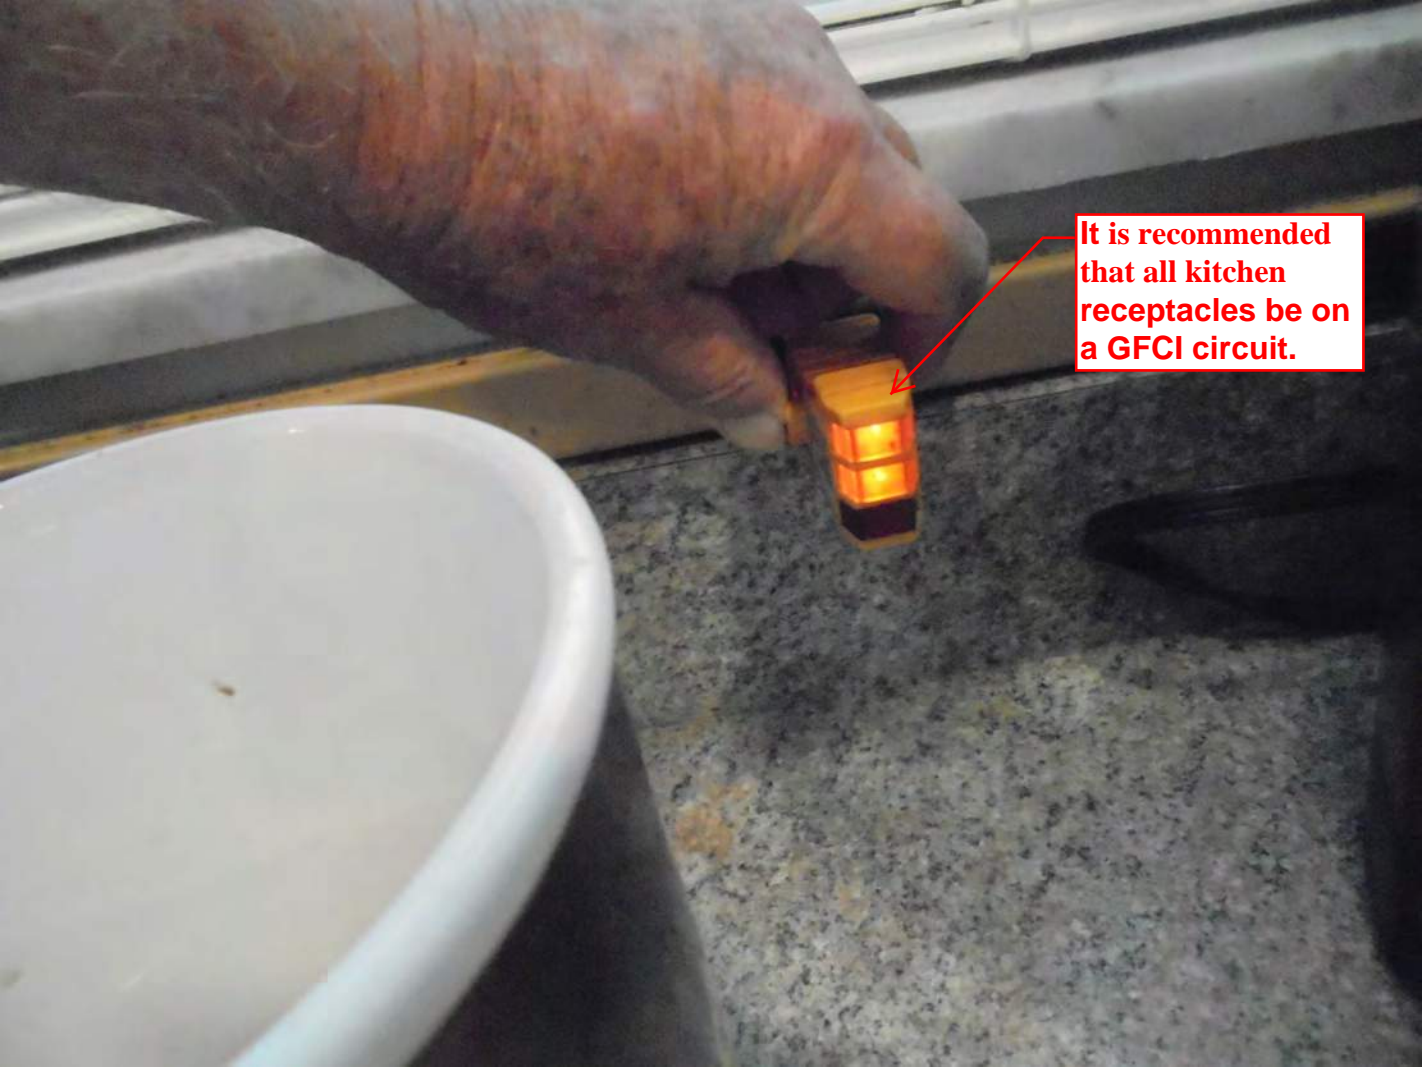
It is recommended that all kitchen receptacles be on a GFCI circuit.

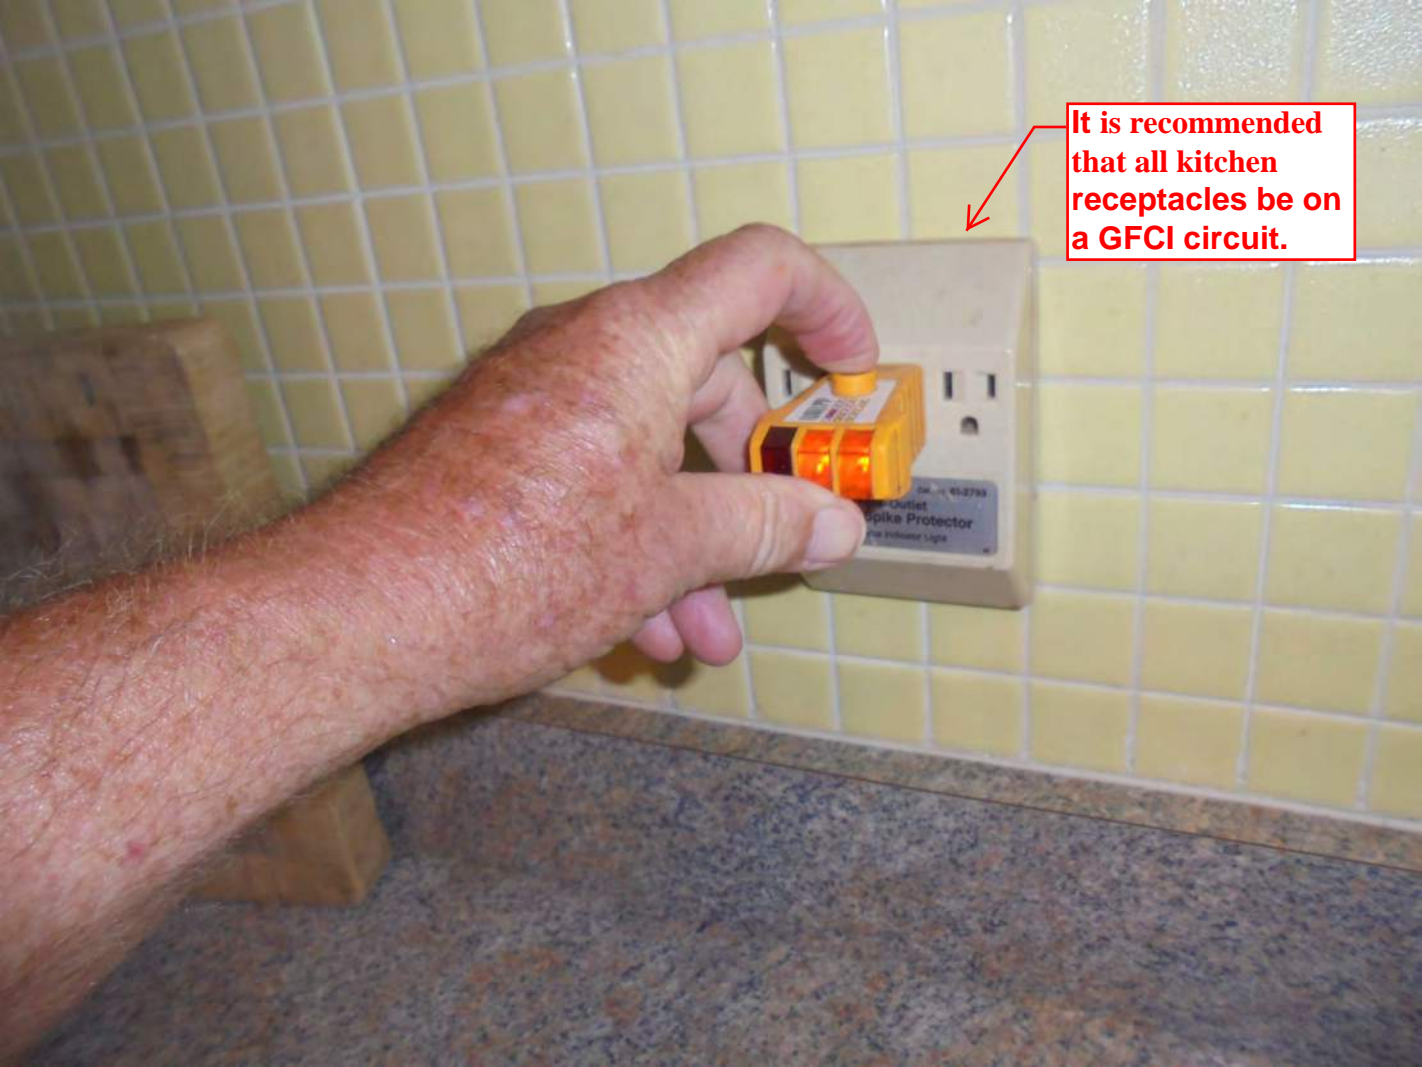
**It is recommended
that all kitchen
receptacles be on
a GFCI circuit.**

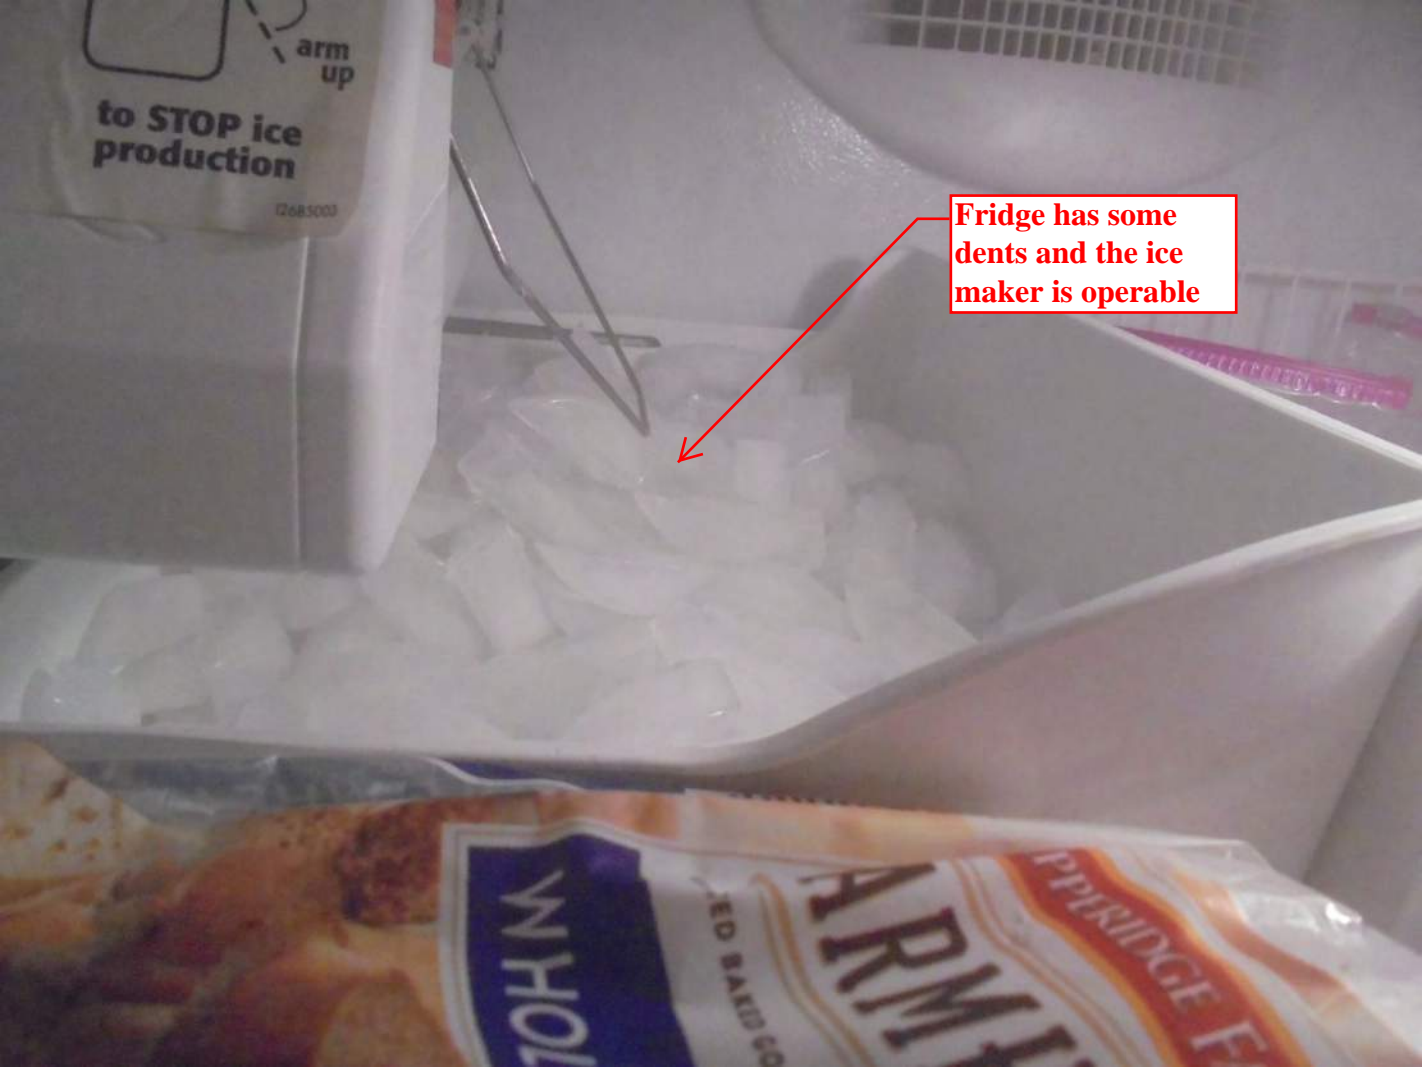
Fridge has some
dents and the ice
maker is operable

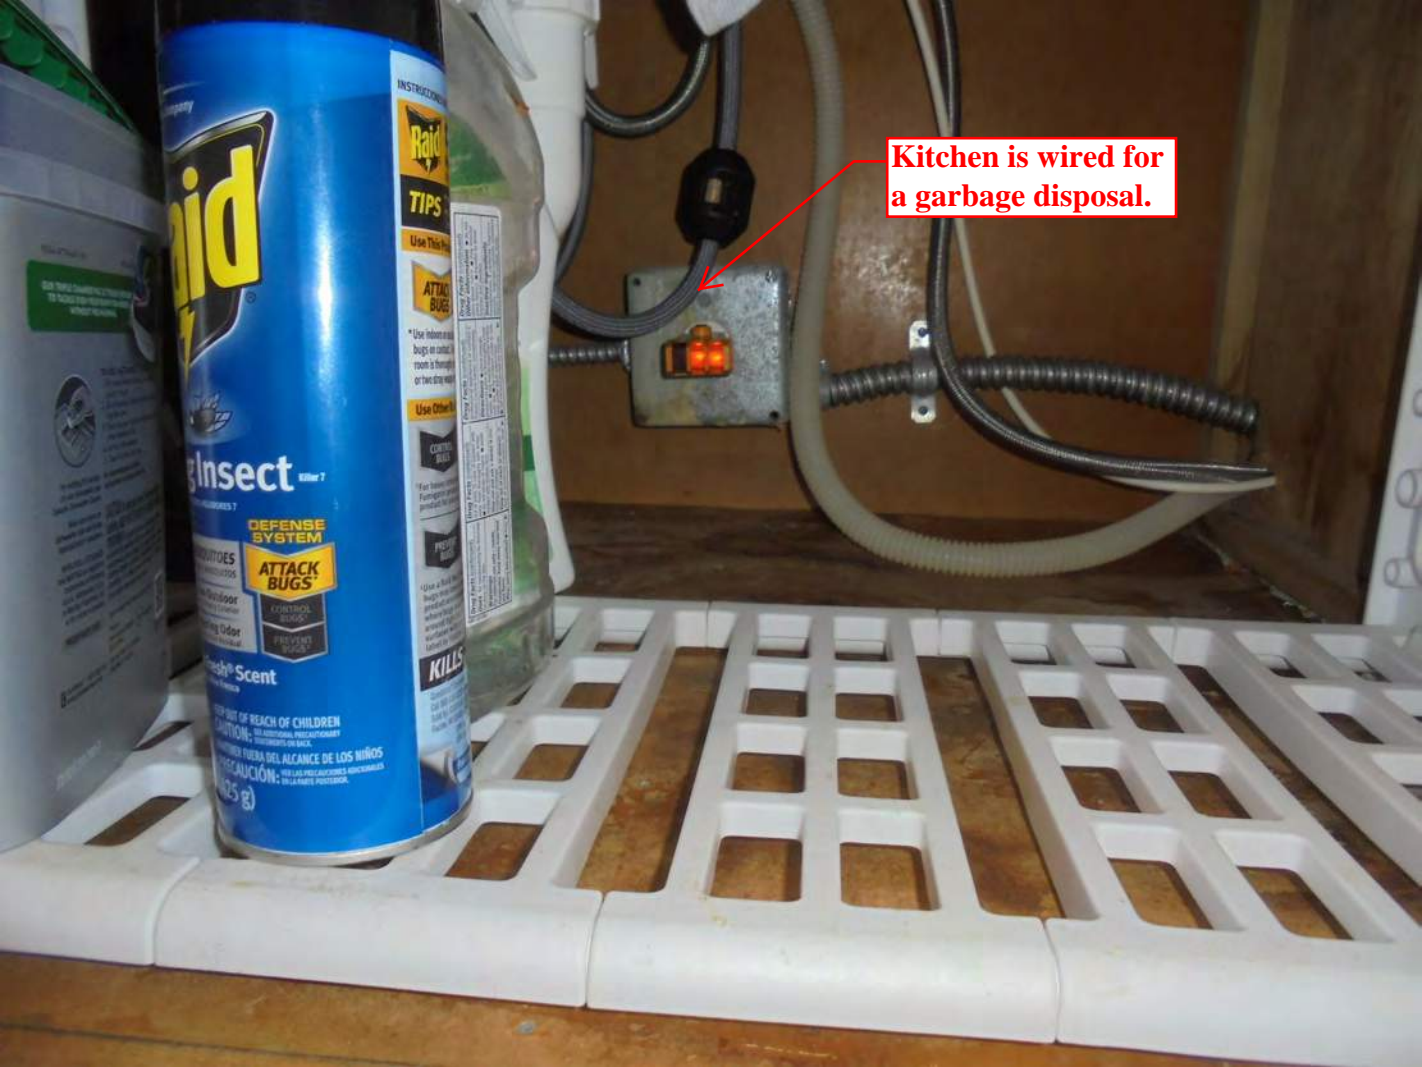
Kitchen is wired for a garbage disposal.

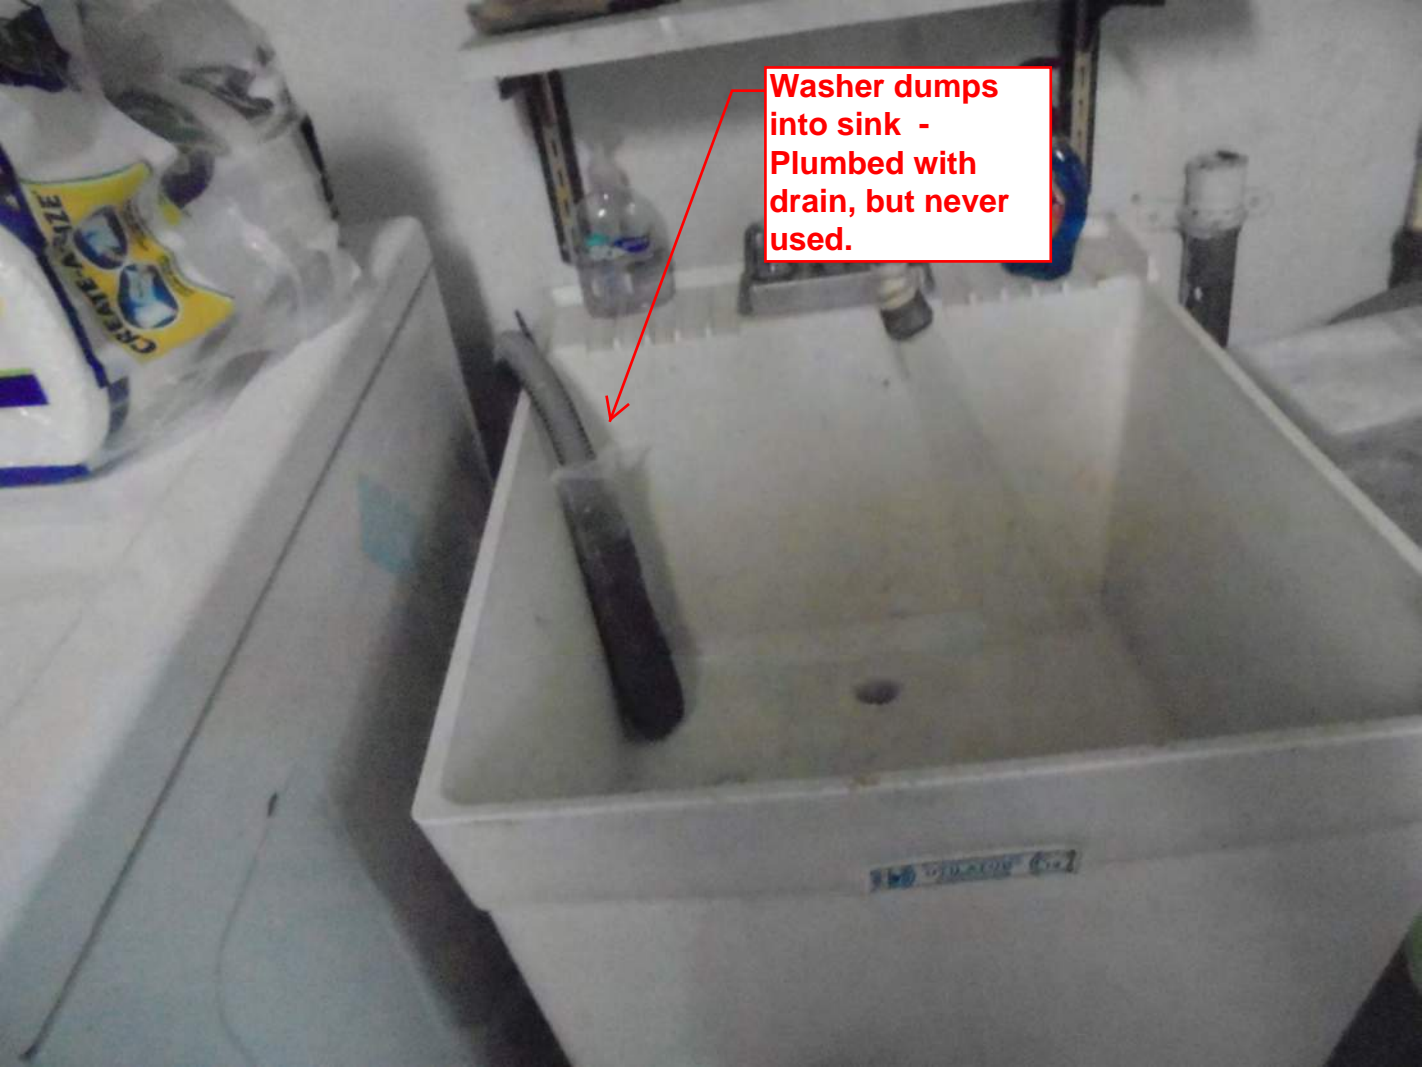
**Washer dumps
into sink -
Plumbed with
drain, but never
used.**

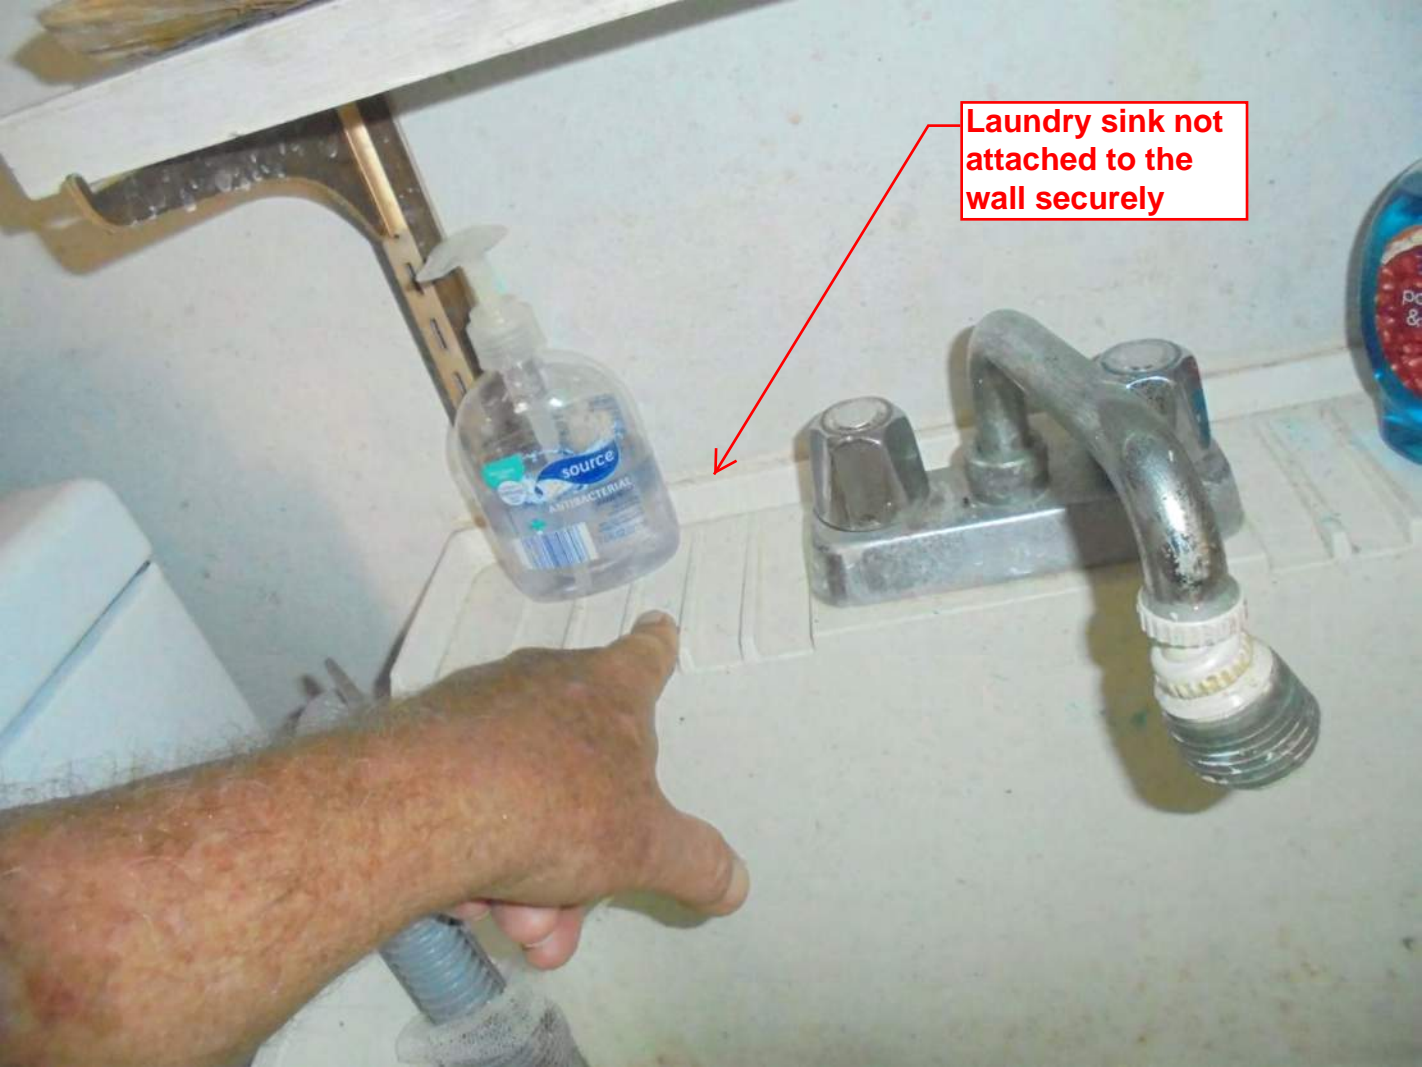
Laundry sink not attached to the wall securely

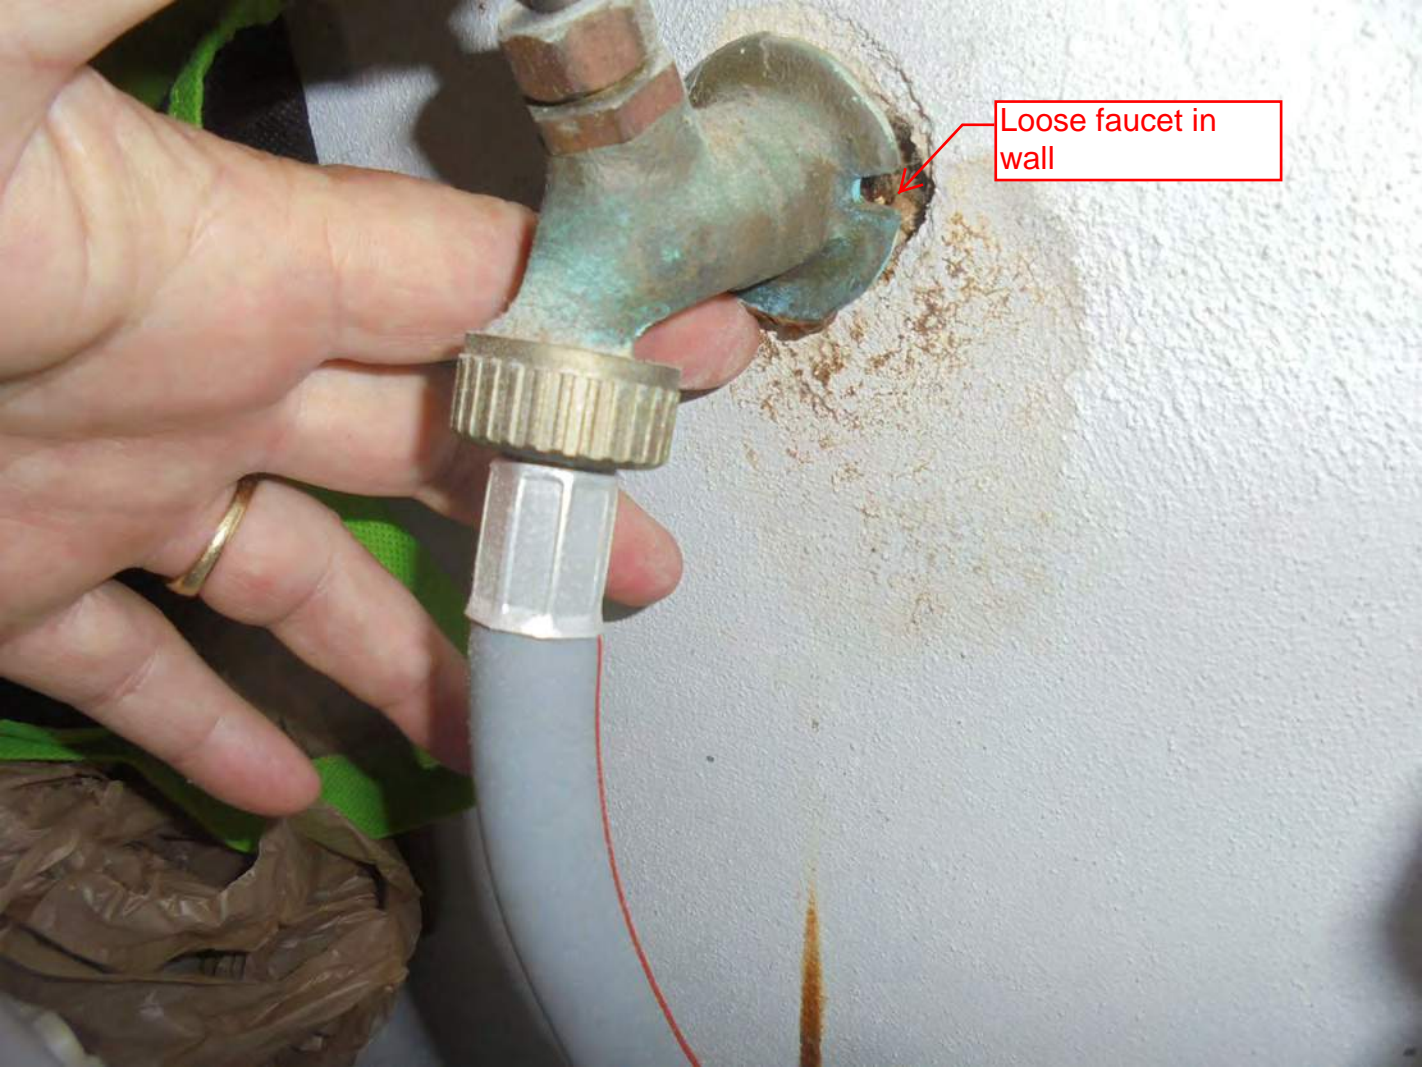
Loose faucet in wall

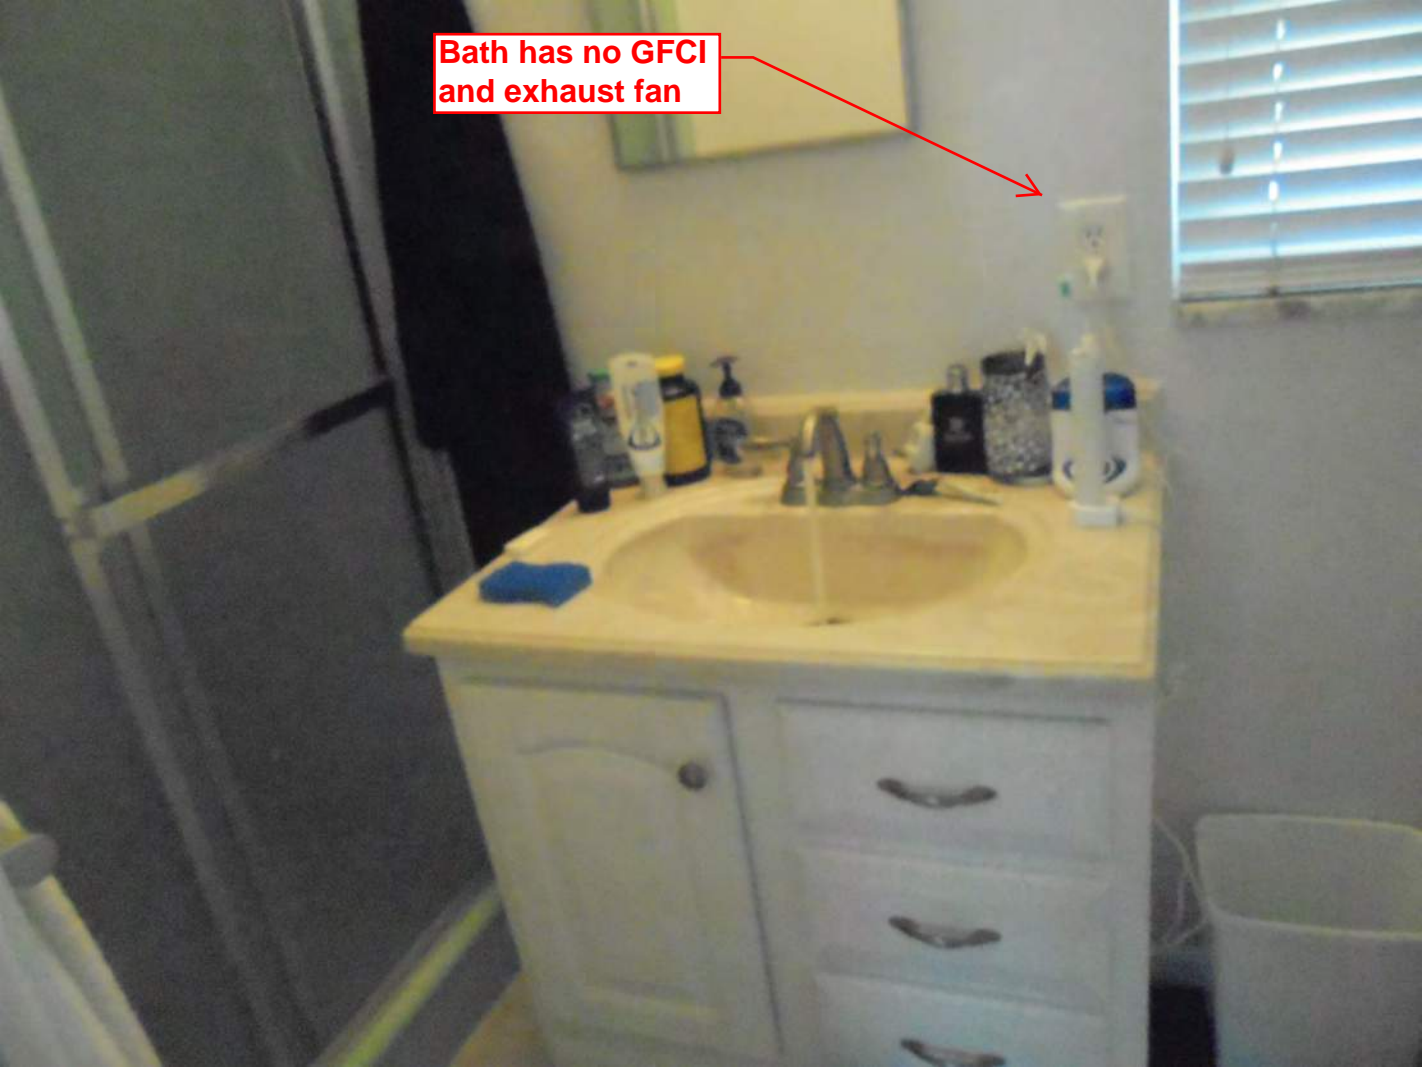
**Bath has no GFCI
and exhaust fan**

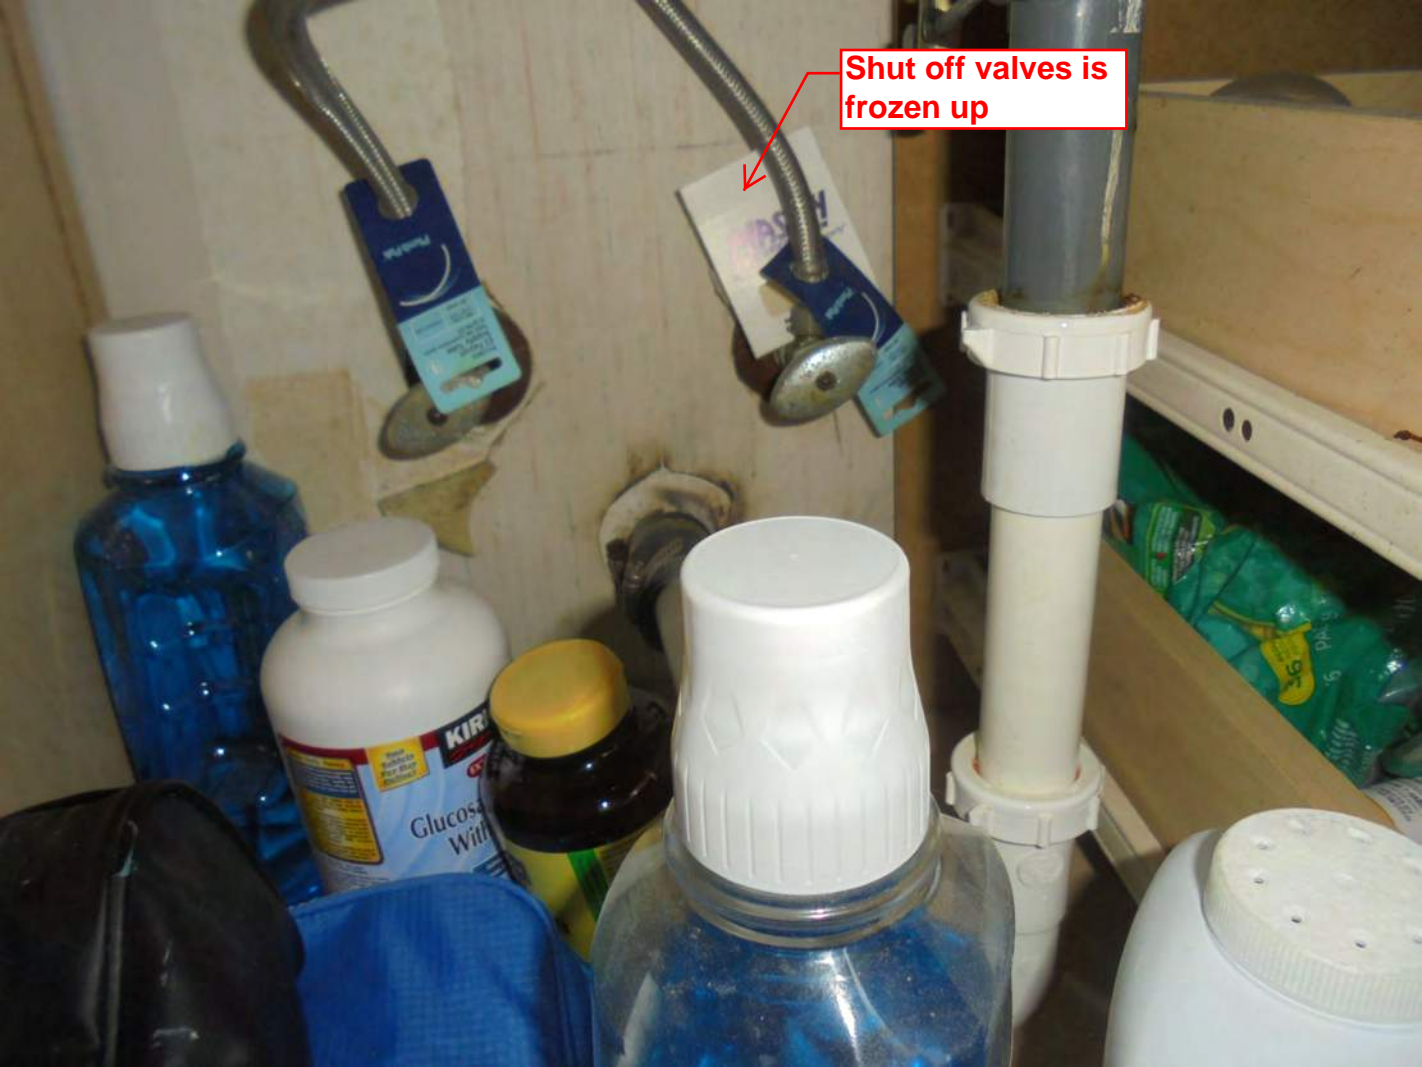
Shut off valves is frozen up
