HOME INSPECTION REPORT

Inspection
Date: 11/06/2017

Prepared For:
Location: Clearwater FL 33756 Prepared By: Gary
Home Inspections Inc.
Seminole Fl. 33776

Report Number: 6816

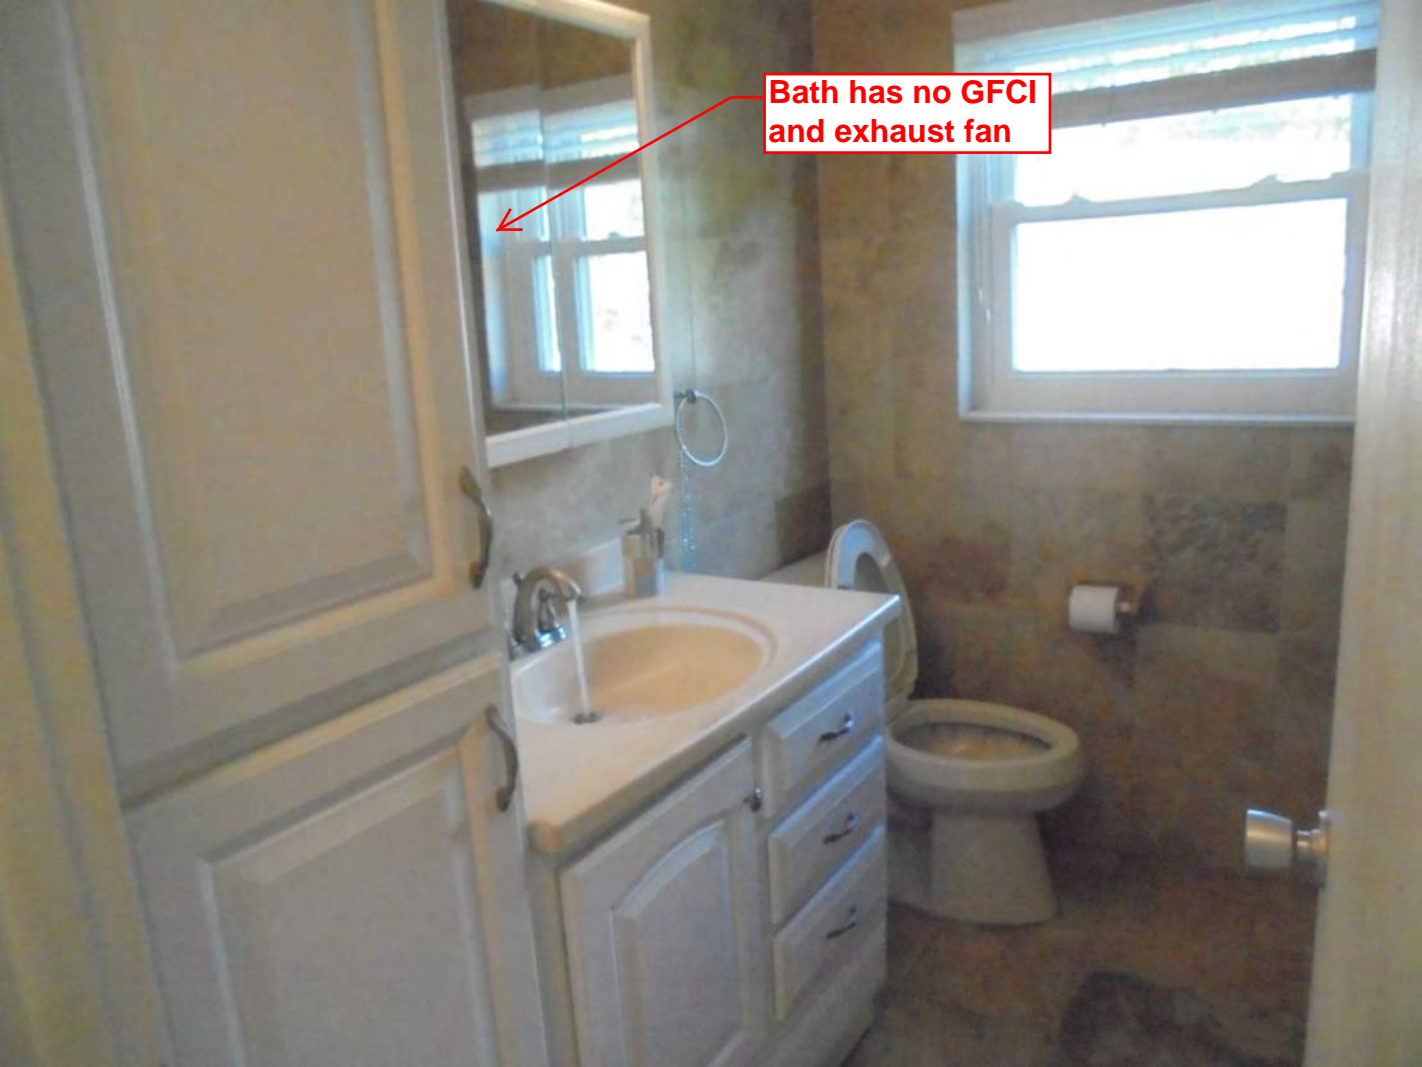
**Bath has no GFCI
and exhaust fan**

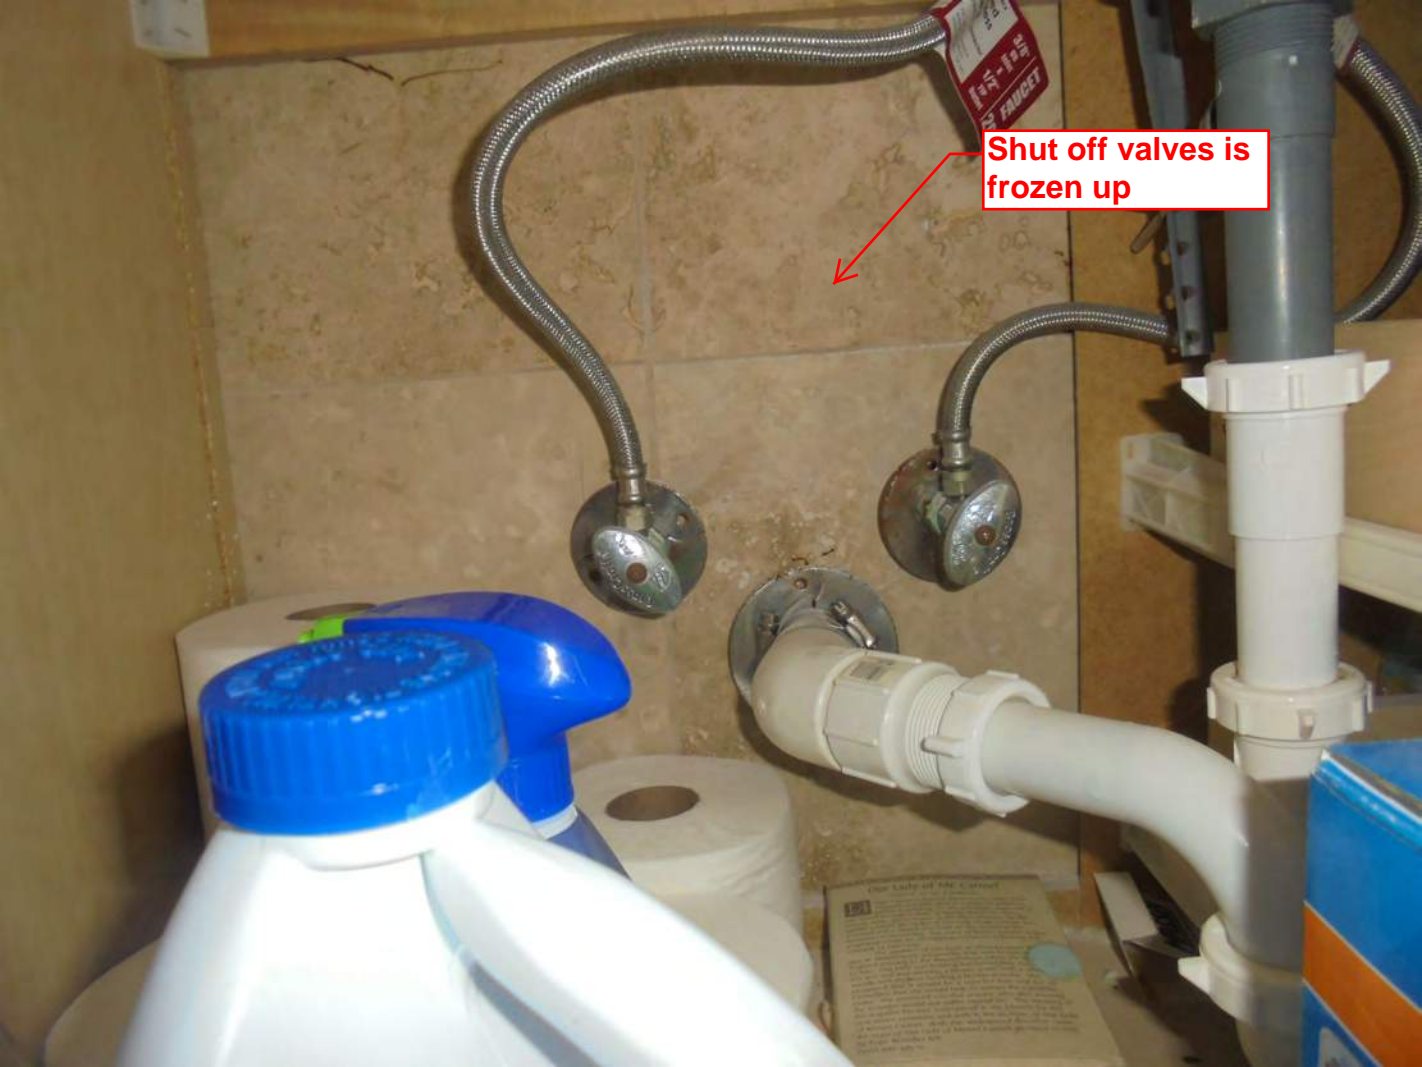
Slow sink drain

Shut off valves is frozen up

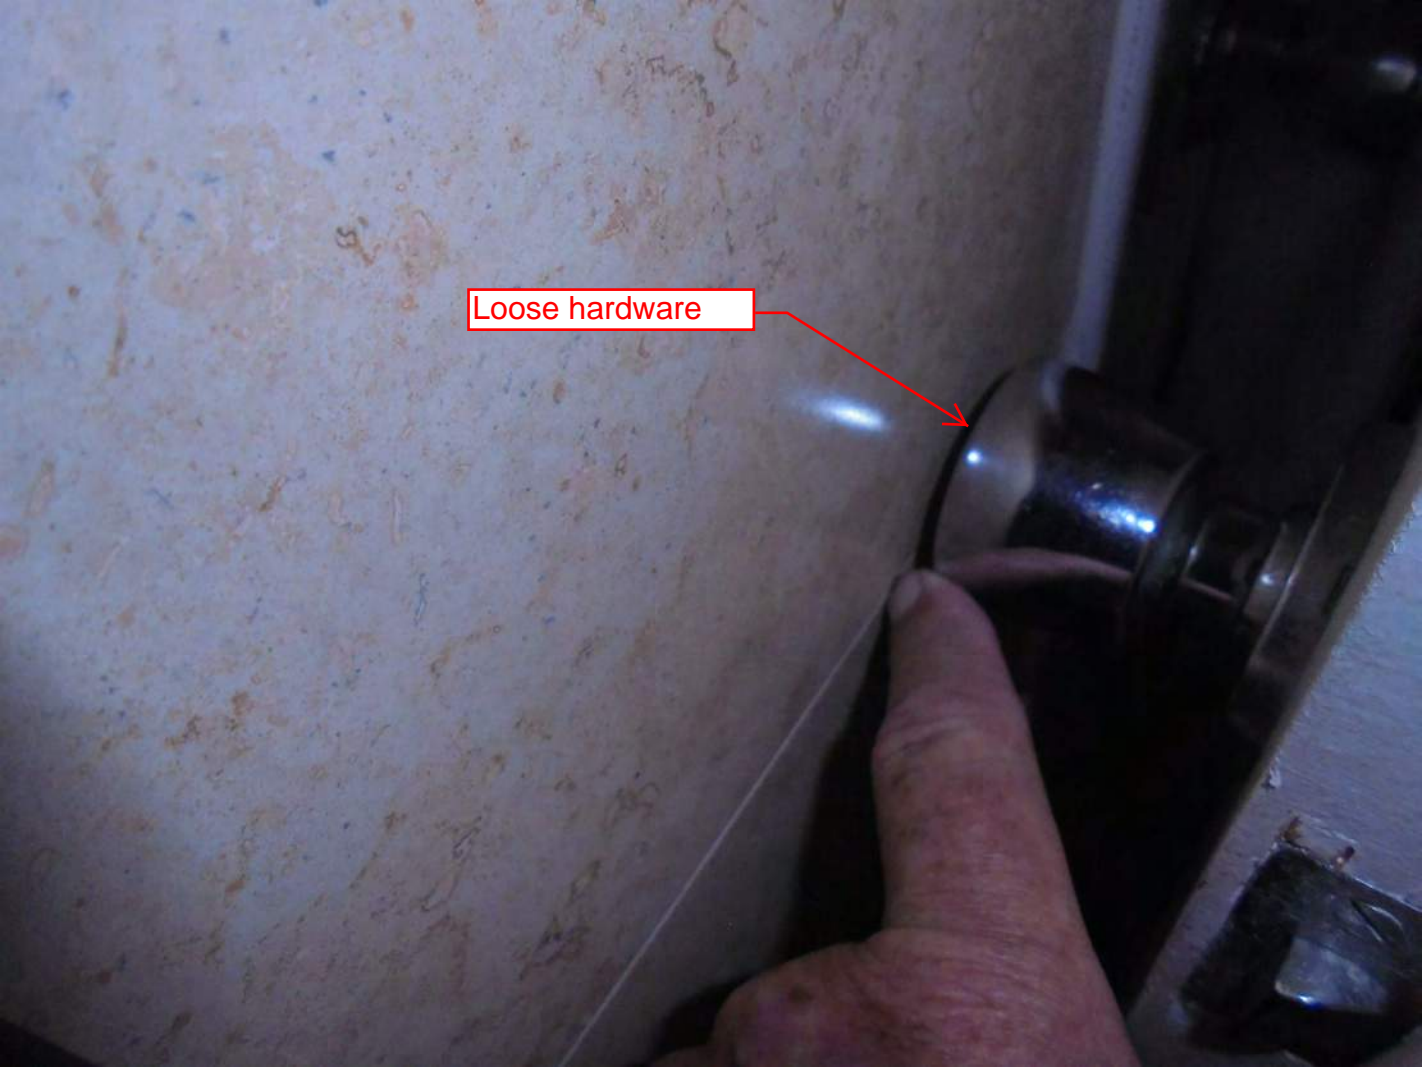
Loose hardware

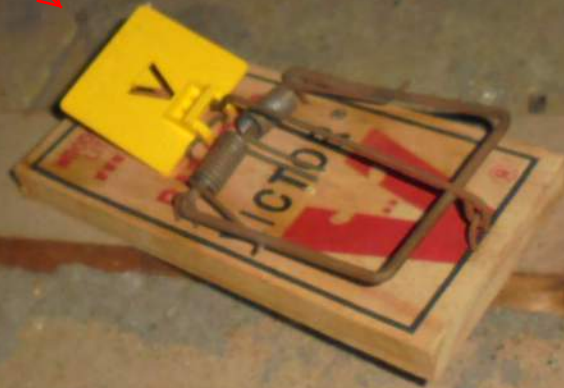
Attic area has evidence of rodent activity (mice) (active trap).

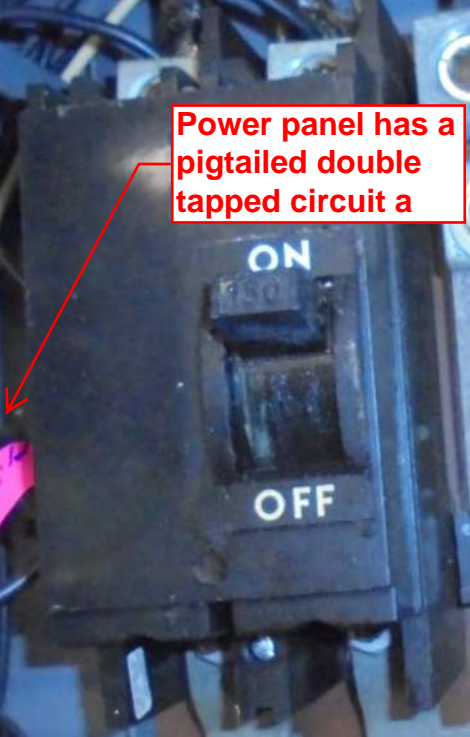
1 single pole turned into a 2 pole (illegal) with a nail to couple the circuits (Fire Hazard).

Power panel has a pigtailed double tapped circuit a

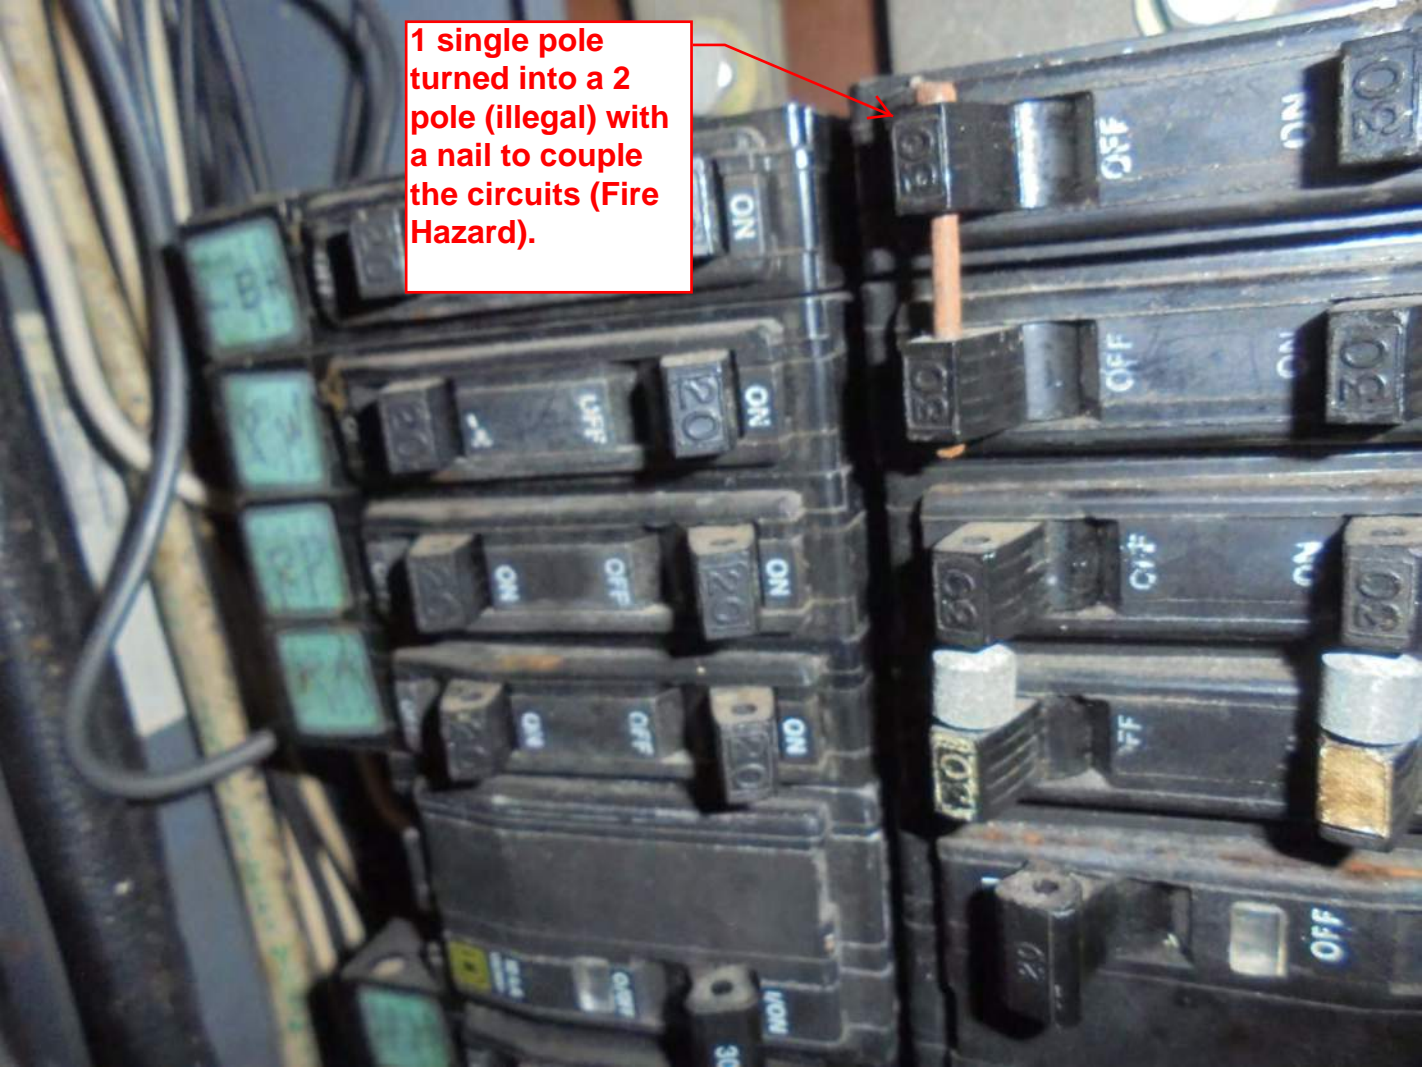
Power panel has a double tapped circuit

1 single pole turned into a 2 pole (illegal) with a nail to couple the circuits (Fire Hazard).

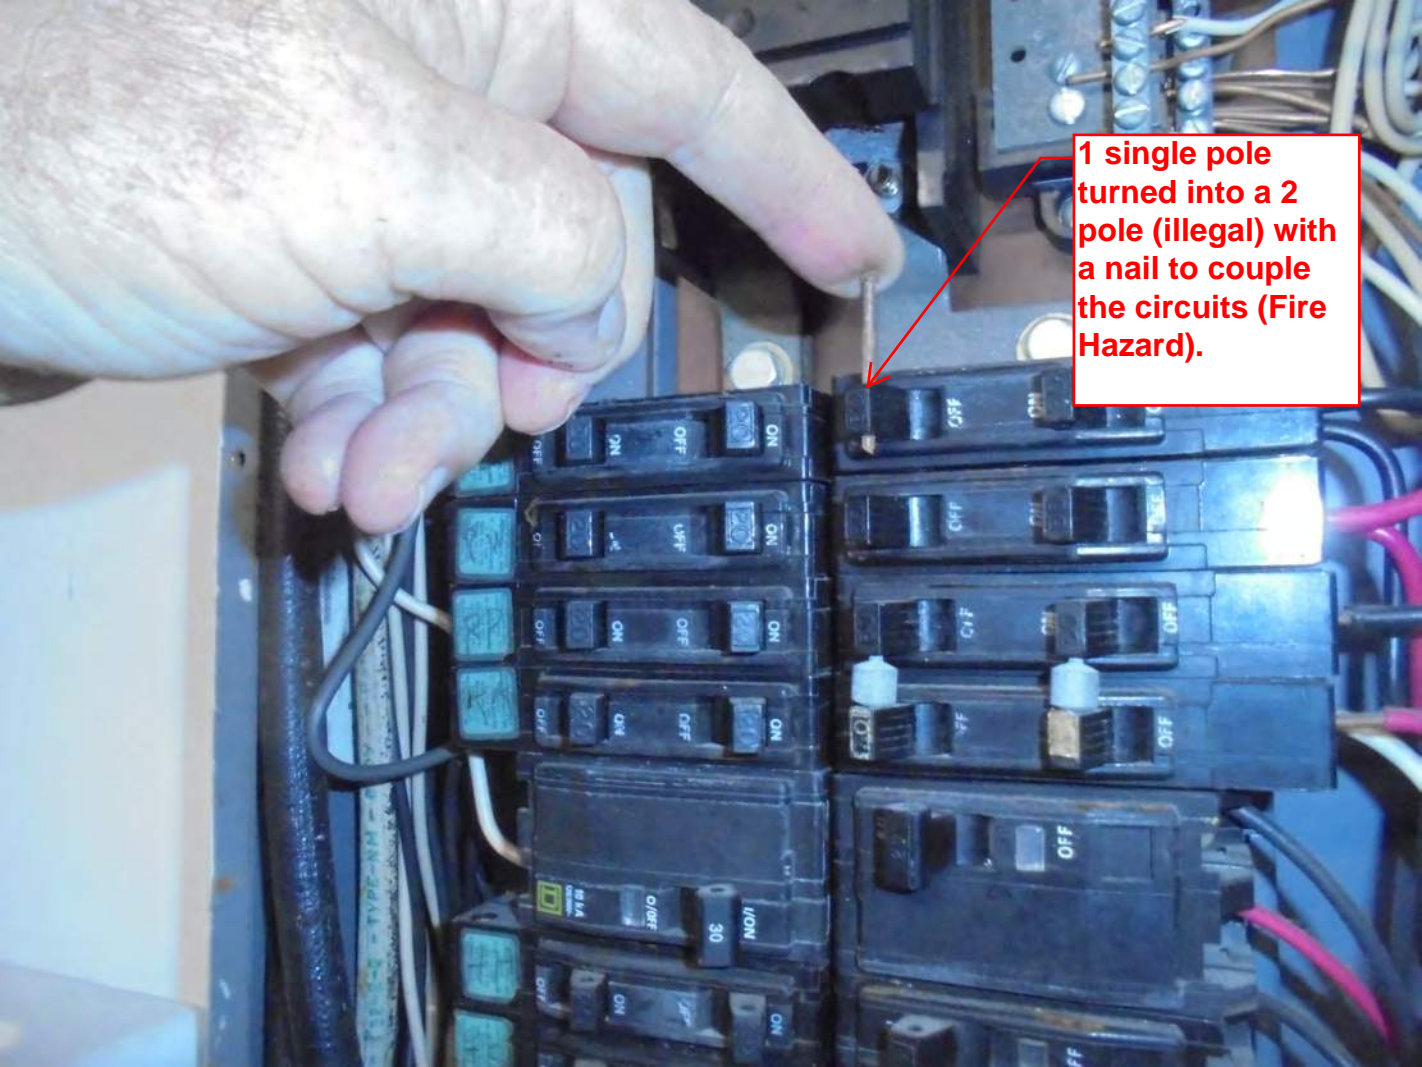
1 single pole turned into a 2 pole (illegal) with a nail to couple the circuits (Fire Hazard).

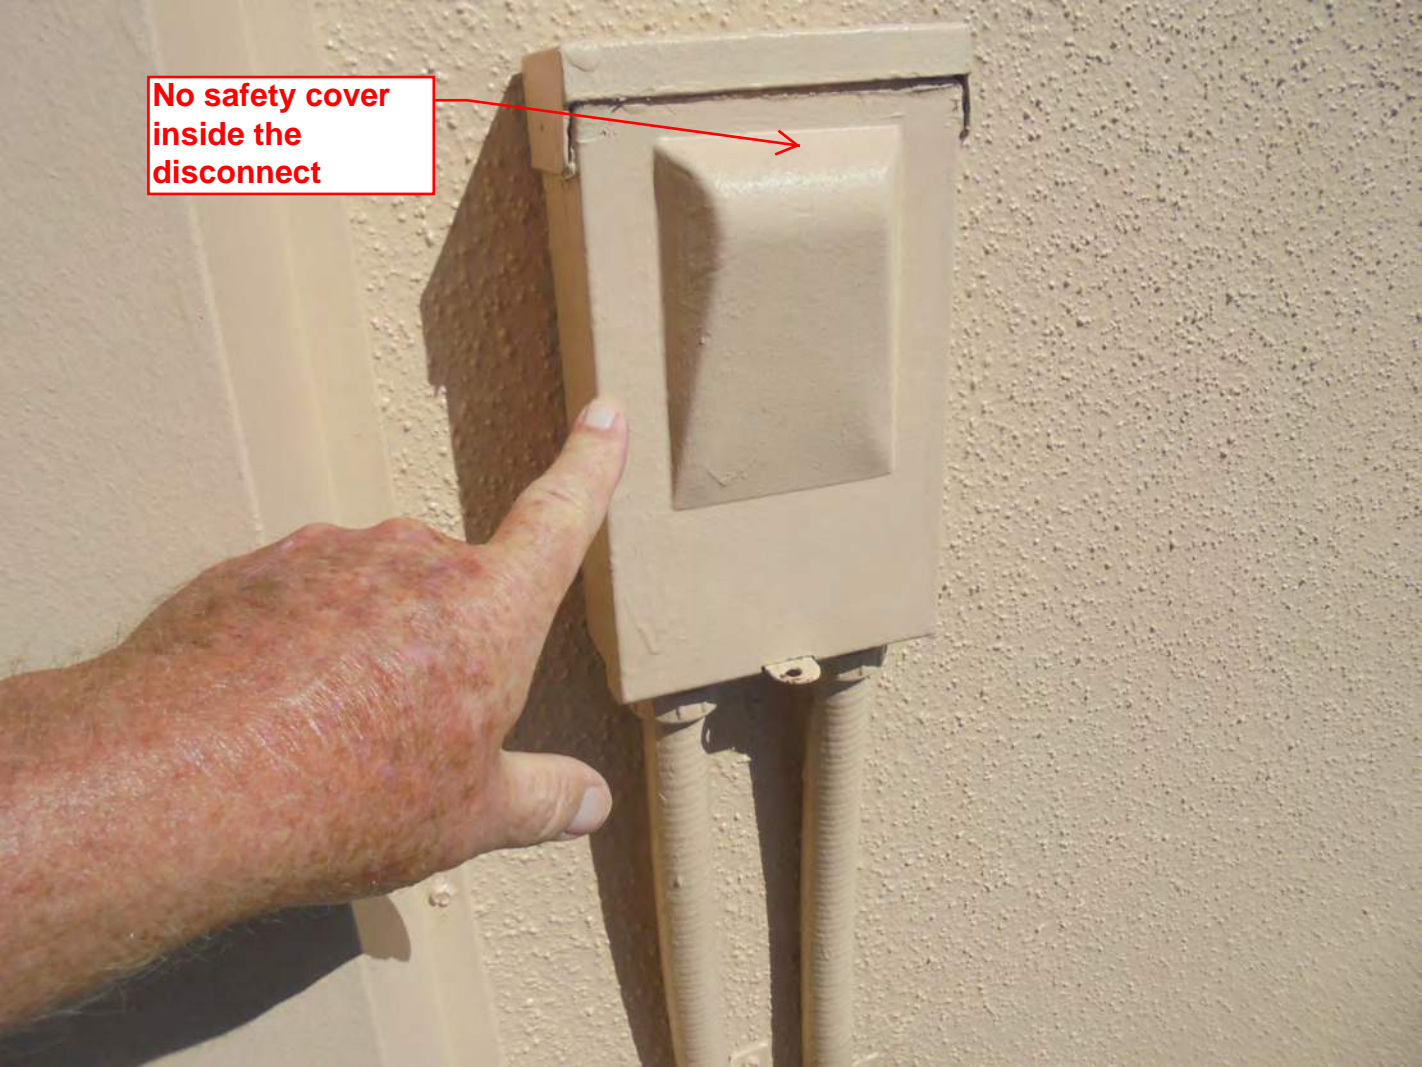
1 single pole turned into a 2 pole (illegal) with a nail to couple the circuits (Fire Hazard).

**No safety cover
inside the
disconnect**

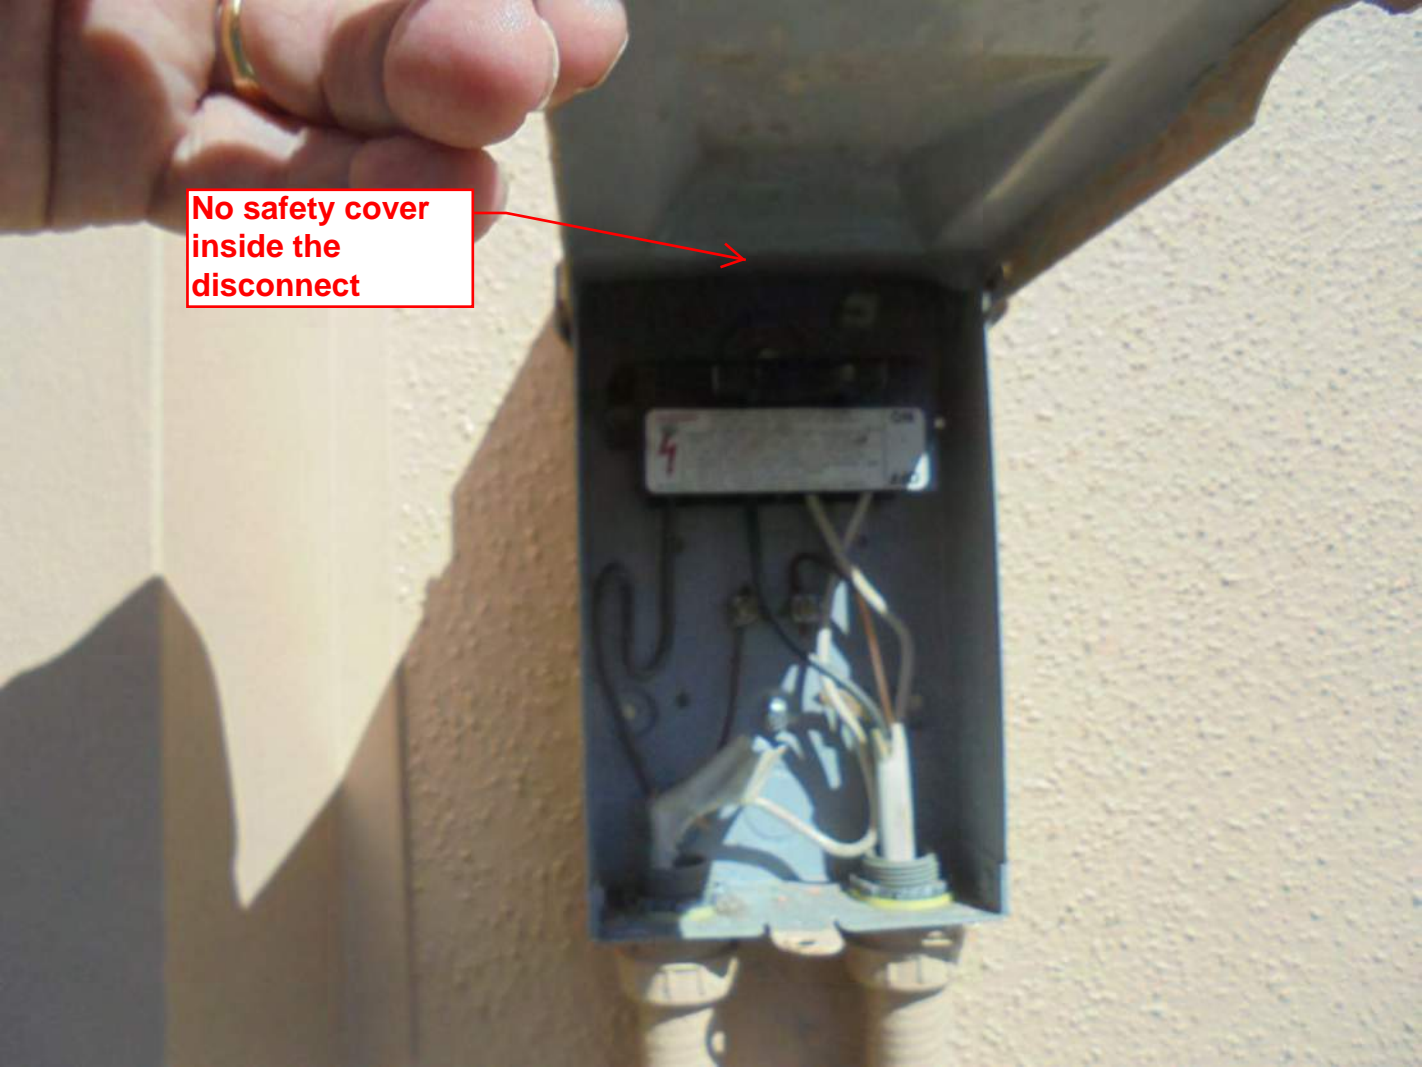
**No safety cover
inside the
disconnect**

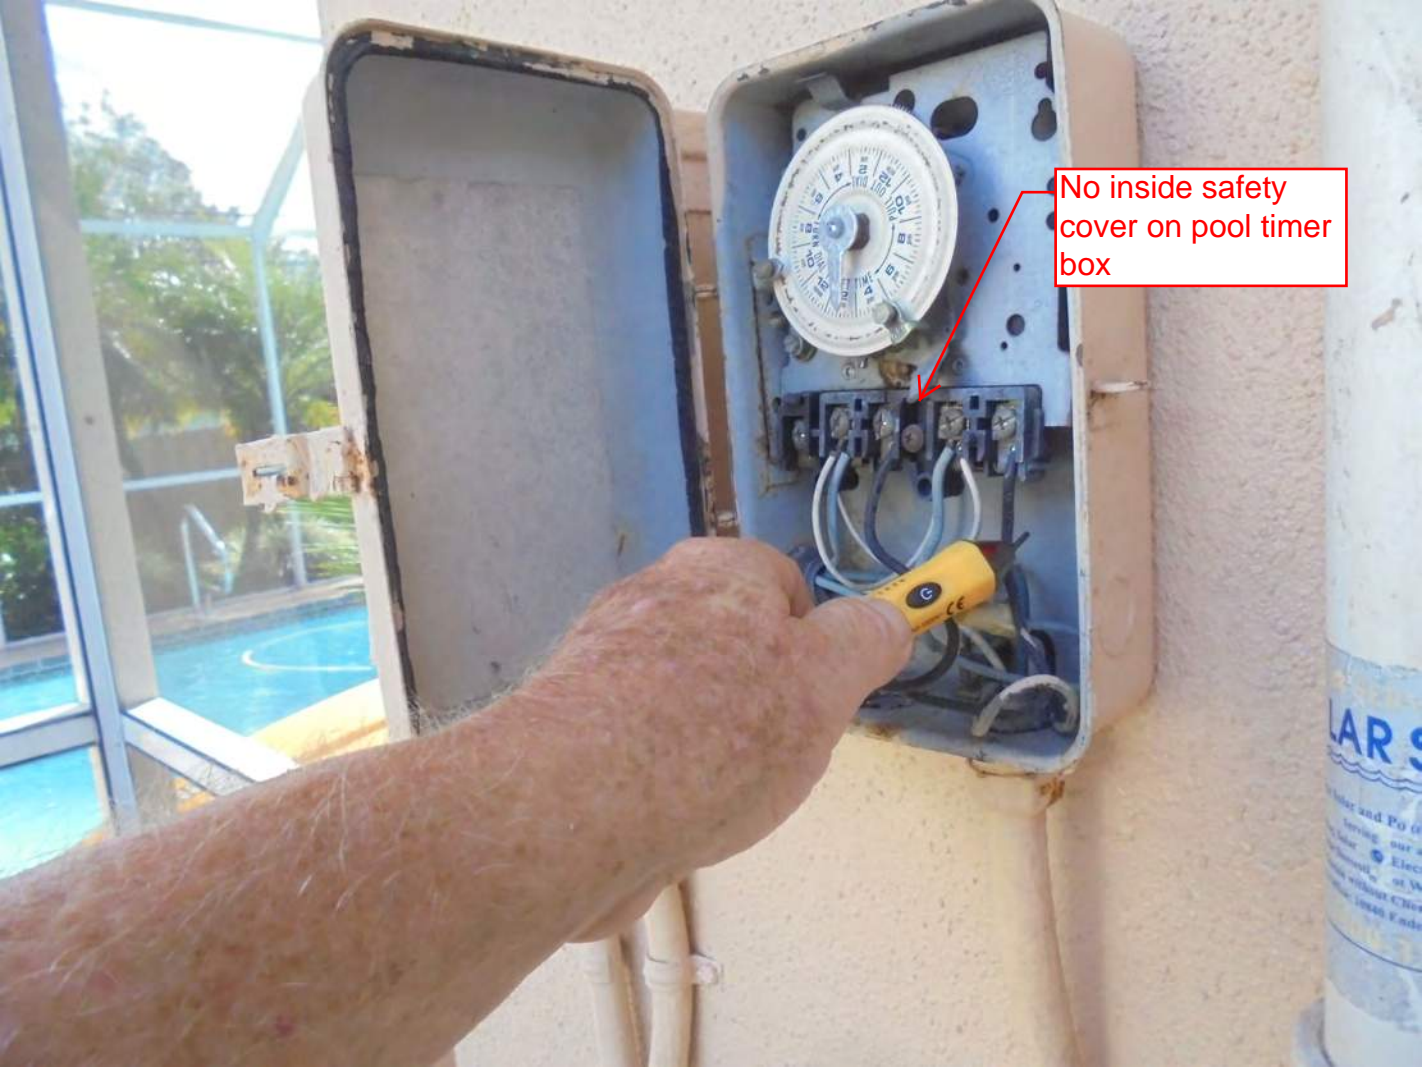
No inside safety cover on pool timer box
